Advanced characterization techniques for SiC and PyC coatings on high-temperature reactor fuel particles

Abstract

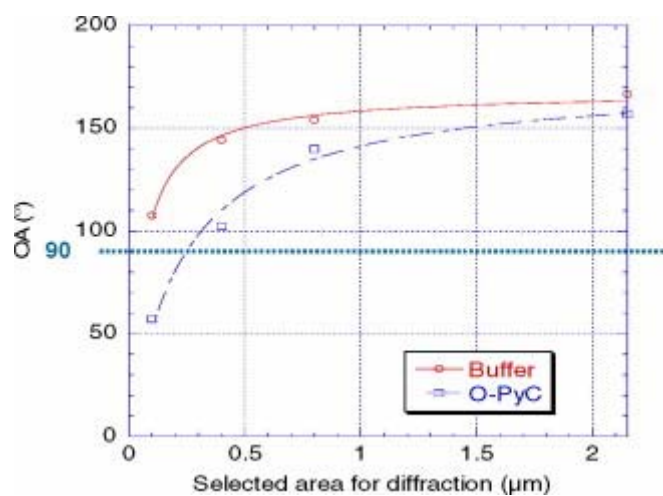
Fig. 6. Typical plot of the electron diffraction data for the buffer and for the dense PyC: OA versus the selected area for the diffraction.

A diffraction pattern is recorded on the desired area of the material and the 0 0 2-plane diffraction is analyzed. Patterns are obtained on larger and larger areas with four aperture diameters: 0.1, 0.4, 0.8 and 2.15 μm . The diffraction patterns show the disorientation of the carbon layers around the anisotropy plane. For perfectly isotropic PyC, the pattern is characterized by a uniform Debye-Scherrer 0 0 2-ring. In the case of a well organized PyC, the pattern exhibits two 0 0 2 arcs which appear perpendicular to the anisotropy plane (carbon layers parallel with the anisotropy plane). The pattern is processed using image analysis software developed in the laboratory. After correction for the film response and for the background, the program performs an azimuthal scan. The intensity distribution is then fitted by two Gaussian curves and the opening angle (OA) is given as the mean value of the two widths at half maximum. This angle is a clear quantitative indicator of isotropy in PyC compared to other methods commonly used and which are based on 0 0 2 dark field images. The higher the OA value, the better the isotropy. An OA value of 90° can be considered to indicate the beginning of an isotropic coating.

An example of the results obtained from such measurements is presented in Fig. 6. Data corresponding to a buffer and an O-PyC layer can be distinguished on the plot. These curves show that PyC isotropy is a scale function of the material. The isotropy thresholds are not the same for the buffer and the dense PyC. The buffer has a structural isotropy (at the scale of a

few tens of nanometers) whereas for the dense PyC a textural isotropy occurs at long range (at the scale of a few hundreds of nanometers or statistical isotropy).

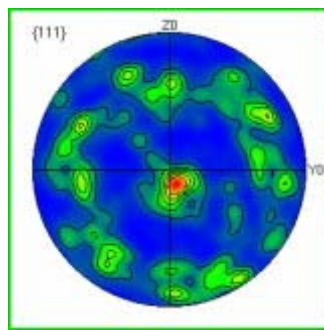
Fig. 8. {1 1 1} pole figure showing the texture of SiC coatings.

Grains exhibit a preferred orientation during growth. The pole figures obtained by EBSD analysis (Fig. 8) show that there is a low 1 1 1 fiber texture (1 1 1 pole parallel to the growth direction). This preferred orientation is commonly observed in CVD SiC deposits [10]. A more comprehensive paper has been published in particular on EBSD analysis of the SiC coatings [11].

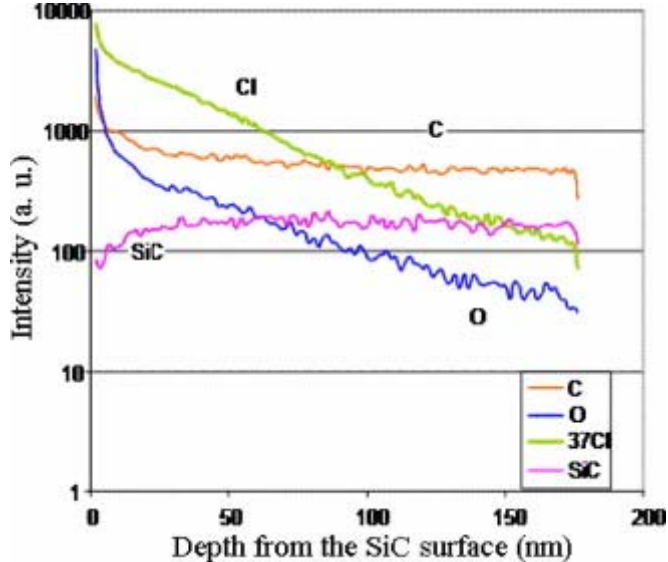
Fig. 13. Depth profile of ³⁷Cl, Si, O, C in the SiC surface.

Chlorine, which may be a residue of the CH_3SiCl_3 gas precursor, was analyzed by electron probe microanalysis (EPMA) on cross sections. Under irradiation, the stable isotope ^{37}Cl becomes radioactive (as ^{36}Cl), so it is of great importance that the deposit contains no chlorine to prevent the release of radioactivity into the environment. The results indicate that it is present in only very small amounts, its concentration is always less than 15 ppm. Additional data are obtained by depth profiles recorded by static secondary ion mass spectrometry (SSIMS). Chlorine is more abundant at the extreme surface but its depth-concentration decreases very rapidly (Fig. 13).
