Advanced characterization techniques for SiC and PyC coatings on high-temperature reactor fuel particles

D. Helary, O. Dugne, Xavier Bourrat

D. Helary, O. Dugne, Xavier Bourrat. Advanced characterization techniques for SiC and PyC coatings on high-temperature reactor fuel particles. *Journal of Nuclear Materials*, 2008, 373 (1-3), pp.150-156. 10.1016/j.jnucmat.2007.05.041 . insu-00159978

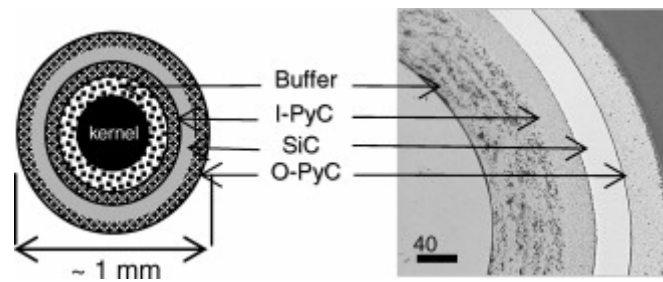
Fig. 1. Particle cross-section showing the kernel, the buffer, the inner PyC (I-PyC), the SiC and the outer PyC (O-PyC).

Fuel particles are produced by a fluidized bed Chemical Vapor Deposition (CVD) process according to the original technique conserved, enhanced and currently investigated by the CEA in Grenoble using simulated coated particles with ZrO_2 - Y_2O_3 kernels and a three fluidized bed furnace. A typical coated particle cross-section is shown in Fig. 1. The kernel is coated by a low density pyrocarbon layer (buffer) and three successive dense layers: an inner dense pyrocarbon layer (I-PyC), a silicon carbide (SiC) layer and an outer dense pyrocarbon layer (O-PyC).

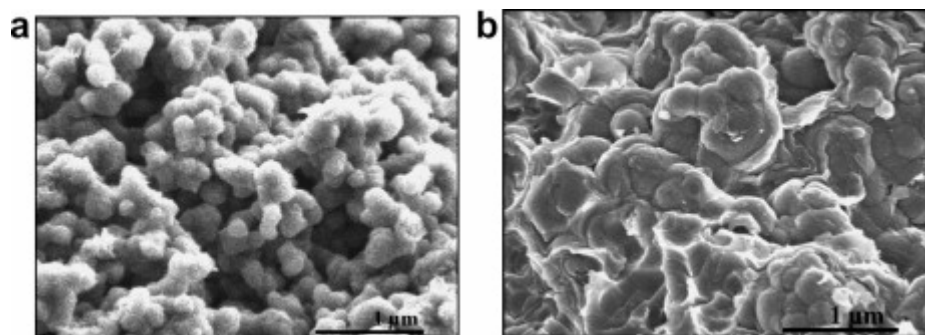
Fig. 2. Fracture surfaces observed by SEM of (a) the buffer and (b) the dense I-PyC.

The buffer and dense PyC texture observed by SEM on fracture surfaces is shown in Fig. 2. The buffer is constituted by concentric growth features (spheroids) 300–400 nm in diameter (Fig. 2(a)). A heterogeneous distribution of large cavities is evidenced. Dense PyC is composed of agglomerated spheroids (Fig. 2(b)) about 400 nm in diameter, typical of reactions in the gas phase (homogeneous growth) [5]. On the fracture surfaces, PyC deposited directly on the surface (heterogeneous growth), can also be distinguished between the agglomerates (Fig. 2(b)).

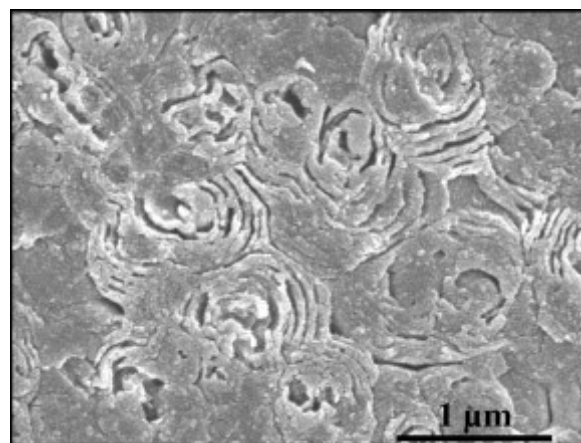
Fig. 3. Polished and etched cross-section of the dense I-PyC observed by SEM.

Murakami chemical etching evidences the main features of the PyC microstructures. The texture of carbon spheroids is clearly visible on a polished and etched cross-section of dense PyC (Fig. 3). They exhibit an onion-like texture with concentric carbon layers. Etching occurs preferentially in regions corresponding to direct PyC coating on the surface. In these regions, the deposit is not concentric (anisotropic fraction or 'layered' carbon).

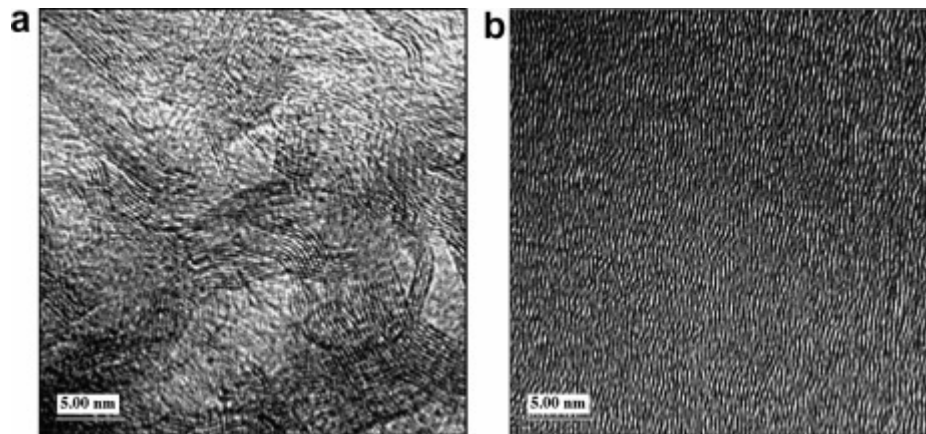
Fig. 4. HR-TEM micrographs of different pyrocarbons: (a) the buffer and (b) the I-PyC. Lattice fringe images correspond to the (0 0 2) carbon layers.

The structures of the buffer and dense PyC observed by High-Resolution TEM (HR-TEM) are totally different. The buffer is composed of randomly oriented piles of long carbon layers (Fig. 4(a)). This nanostructure is known to favor low density via significant inter-layer porosity. Carbon layers deposited in the case of I-PyC are shorter and arranged in compact piles (Fig. 4(b)). These observations are consistent with data from the literature. In the 1970s, Pollman et al. [1] reported on the state of the art of TEM analysis, and noted that three different structural arrangements (referred to as ‘tangled fiber’, ‘mosaic’ and ‘layered’) can occur in PyC. A comparison of this classification well described in [1] with observations made in the present study indicates a ‘tangled fiber’ structure in the buffer and a ‘mosaic’ structure in the dense PyC.

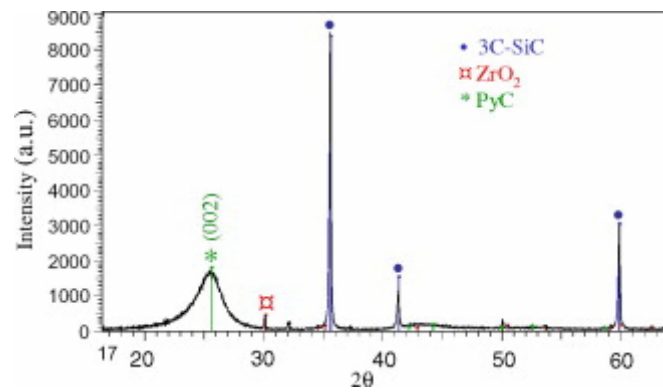
Fig. 5. The XRD pattern of HTR particles.

The apparent crystallite size (L_c) and d_{002} -spacing were obtained using X-ray diffraction. The Scherrer relation and Bragg’s law were used respectively to determine L_c and d_{002} -spacing. The particles were measured directly (all particles are in the same plane). For Cu K α radiation, the attenuation of the incident beam is about 98% at the outer surface of the I-PyC layer (SiC is a stronger X-ray attenuator). This indicates a preponderant contribution of O-PyC to the (0 0 2) diffraction peak (Fig. 5). Therefore, calculations can only be made for the O-PyC layer. L_c is about 30 Å; this result is very similar to that reported in the 1970s for ‘mosaic’ structure [1]. d_{002} is about 3.47 Å and is typical of turbostratic pyrocarbons.

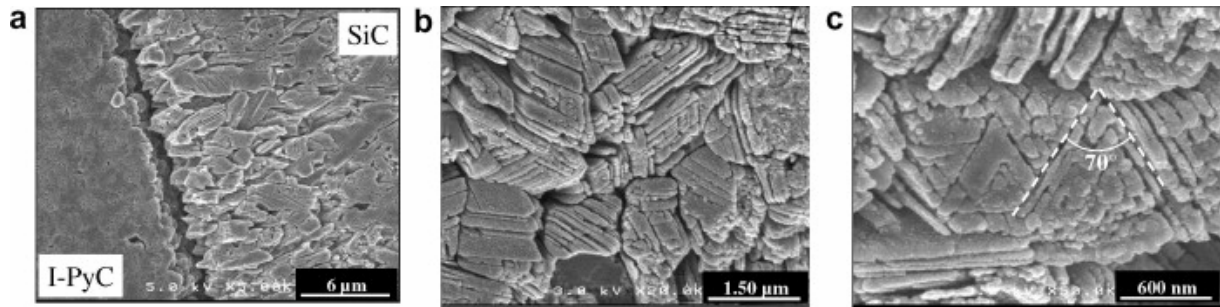
Fig. 7. SEM micrographs of SiC etched for 60 min (a) polished section perpendicular to the plane of deposition showing columnar grains; (b) and (c) sections parallel to the plane of deposition showing planar faults.

Etching reveals the presence of fine columnar grains in the equatorial polished section (Fig. 7(a)). The width and length are about 1 μm and about 4–5 μm , respectively. It seems that the etching is stronger in the first microns of near the I-PyC/SiC interface (Fig. 7(a)). This phenomenon may be due to the existence of very small grains. This heterogeneous microstructure is confirmed by EBSD measurements. EBSD maps illustrate the grain size distribution and show that finer grains are present at the beginning of the SiC coating and coarser at the end [10]. The interface between I-PyC and SiC is expected to be strong, because the small SiC grains can penetrate into the I-PyC porosities (the outer surface of the I-PyC is rough and porous). A tightly bonded I-PyC/SiC interface is important because bond separation can result in stress concentration in the SiC layer that may lead to the failure.

Moreover the etched grains exhibit many apparent planar faults, which cross the entire grain or stop inside (Fig. 7(b)). They are relatively homogeneously dispersed over the grains and often tend to exhibit a particular orientation relationship at about 70° to each other (Fig. 7(c)). Similar features were evidenced by Gulden, from General Atomic, in the 1970s [9].

Fig. 9(b) shows an example of such stacking faults on a $\{1 1 1\}$ β -SiC surface. It is interesting to note that the dihedral $\{1 1 1\}$ angle between two set of stacking faults that intersect is 70.5° , i.e. similar to what is observed on the etched SiC (Fig. 7). This is the interplanar angle of crystallographically equivalent (1 1 1) planes.

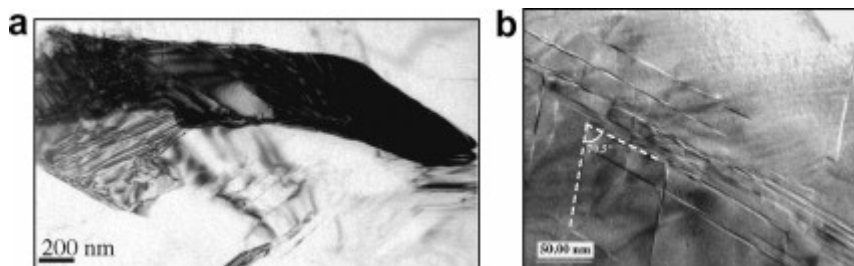
Fig. 9. (a) Bright field TEM image showing a columnar β -SiC grain divided into sub-grains, (b) HR-TEM image showing stacking faults lying on $\{1\ 1\ 1\}$ planes.

TEM examination at higher magnification confirms the previously described grain dimensions and morphology, and demonstrates the occurrence of sub-grains in some of them (the coarser ones). Two sub-grains can be observed in Fig. 9(a): one with dark contrast and another isomorph with a grey one. According to the SAED diagrams, the crystallographic nature of the coating is β -SiC. SiC exists in a wide variety of crystallographic forms known as polytypes, which differ from one another only in the (1 1 1) stacking of the SiC diatomic layers (Si–C). β -SiC or 3C is the cubic form of SiC. When the deposit is observed along the $[112, \bar{0}]$ direction, stacking faults oriented parallel with the (1 1 1) planes, can be identified.

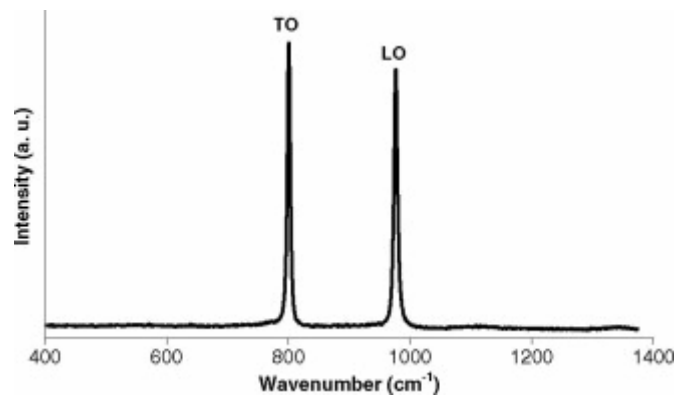
Fig. 10. First-order Raman spectrum obtained on SiC cross-section.

HR-TEM observations show that regular hexagonal faulted structures (polytype with large period) are not abundant. It is more common to find some random stacking faults which correspond to one-dimensionally disordered polytype [12]. In this case, diffuse streaking of lesser intensity appears in the (1 1 1) directions on the corresponding SAED diagram. The fact that hexagonal polytypes (α -SiC) are not abundant is confirmed by X-ray diffraction (XRD) (Fig. 5) and Raman microspectrometry analysis (Fig. 10). The α phase was never detected with either technique. Raman spectra show two sharp peaks at 797 cm^{-1} (transverse optic: TO) and 976 cm^{-1} (longitudinal optic: LO), typical of the 3C polytype. The fact that there is no evidence of any secondary phase contradicts earlier results [13] reporting a small fraction of α -SiC measured by XRD, although the processing conditions were not exactly the same.

As already noted, all the deposits characterized by Raman microspectrometry consist exclusively of β -SiC. Raman spectra also demonstrate that there is no excess carbon and

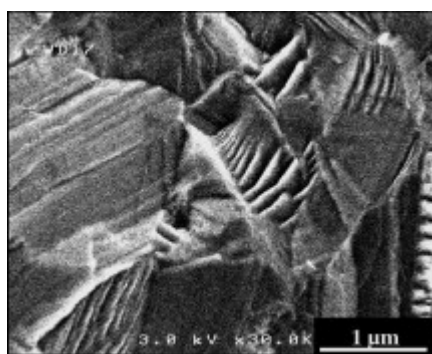
Fig. 11. Fracture surface of SiC observed by SEM.

The quality of grain boundaries is of considerable interest because they play an important role during the migration of fission products. Preliminary observations directly on fracture surfaces reveal that cleavage is mainly transgranular (hackle marks in Fig. 11). This is in line with high-purity and porosity-free grain boundaries. This feature is confirmed by TEM examination and energy dispersive X-ray (EDX) spectrometry coupled with TEM. No intergranular porosity is apparent and EDX results suggest that no segregation exists. It may thus be concluded that such grain boundaries are of high quality.

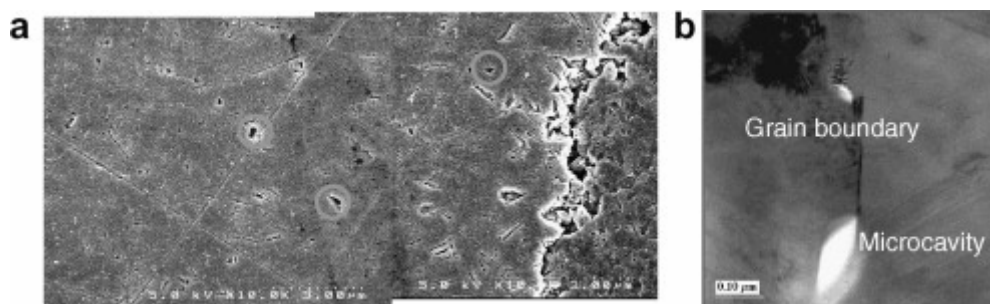
Fig. 12. (a) SEM micrograph of SiC etched for 10 min. Polished section perpendicular to the plane of deposition. (b) TEM micrograph of SiC.

SEM observations of fracture surfaces and external cap show no apparent pores. It would thus appear that there is no crack initiator in the SiC deposit. This feature was checked by using a short etching procedure which revealed some potential cracks: microcavities are present in the area close to the SiC/I-PyC interface (rings in Fig. 12(a)). These microcavities are also detected by TEM examinations (Fig. 12(b)). When the internal gas pressure increases, a tensile hook stress can develop in the SiC layer, flaws can then propagate and generate radial cracks in the SiC deposit.
