## Modelling and back-analysing failures in steep limestone cliffs

Magali Frayssines, Didier Hantz

Magali Frayssines, Didier Hantz. Modelling and back-analysing failures in steep limestone cliffs. *International Journal of Rock Mechanics and Mining Sciences*, 2009, 46 (7), pp.1115-1123. 10.1016/j.ijrmms.2009.06.003 . insu-00498736

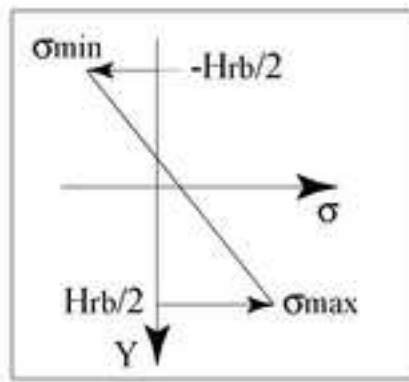
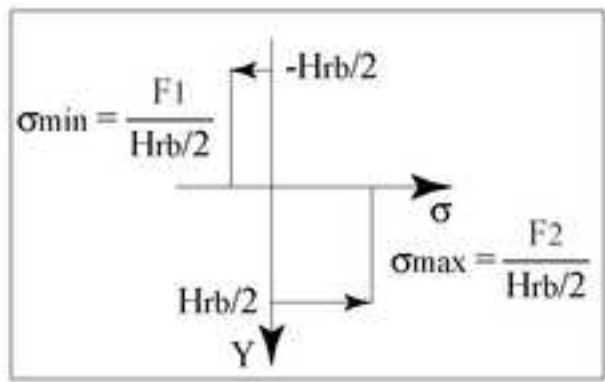
Figure 9

Note that for design purposes, the hypothesis of a linear distribution of the normal stress (Fig. 9A) is more conservative (or more pessimistic) than the hypothesis of a rectangular distribution (Fig. 9B), which is adopted, for example, in the UDEC code [21]. For the second hypothesis the calculation would lead to the following Eq. (20):

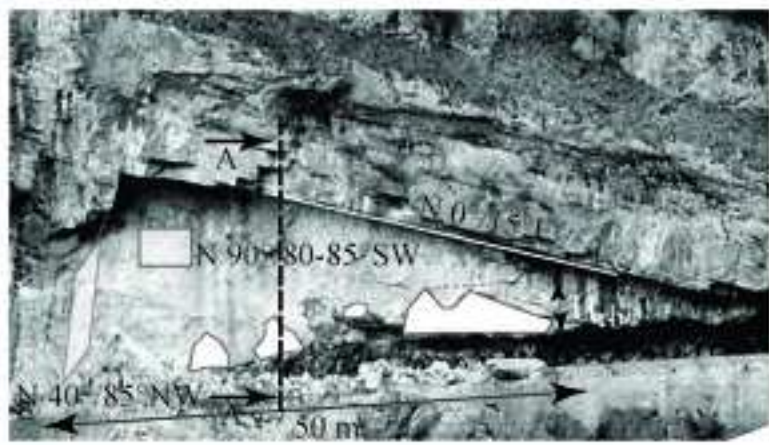
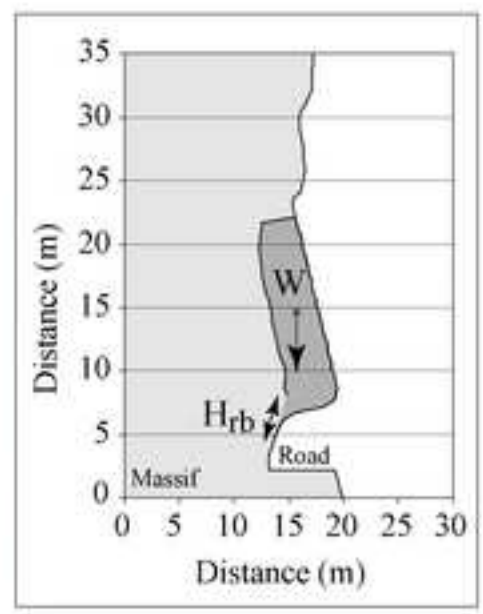
Figure 10

Fig. 10. (A) view of the scar of the Ranc rock fall, with the rock bridges in white and (B) cross-section A-A of the cliff before failure with the position of the equivalent rock bridge.  $W$ : weight of the unstable block ;  $H_{rb}$ : height of the equivalent rock bridge.

The Ranc rock fall occurred on 30th January, 2004, 50 Km SW of Grenoble (Fig. 2). 2200 m<sup>3</sup> of rock collapsed onto the road, killing two people in a car. The cliff is 150 m in height, strikes N80 and dips 85-90° to the South. The fall occurred where the cliff formed an overhang due to the construction of the road 150 years ago (Fig. 10B). The limestone beds strike N0°, dip 15° to the East, and they are cut perpendicularly by 2 joint sets N100°/90° (J1) and N33°/75°SE (J2). The scar is 50 m wide, about 20 m high and the mean thickness of the fallen mass was approximately 2.5 m. The failure surface is made up of a bedding plane N0°/15°E and two planes, N90°/80-85°S and N40°/85°NW belonging respectively to the joint sets (J1) and (J2) (Fig. 10A). In the major part of the scar, the rock is coated by a calcite crust (yellowish-orange colour). Intact rock fracture surfaces have been observed in the lower part of the plane N90°/80-85°S (Fig. 10). These fresh fracture surfaces, which cover an estimated area of 52 m<sup>2</sup> (5% of the whole scar area), are due to the failure of rock bridges. The equivalent rock bridge considered in the analysis has a height of 3.5 m and a width of 35 m. We obtained tensile strength and cohesion values equal to 3.2 MPa and 10.5 MPa respectively.

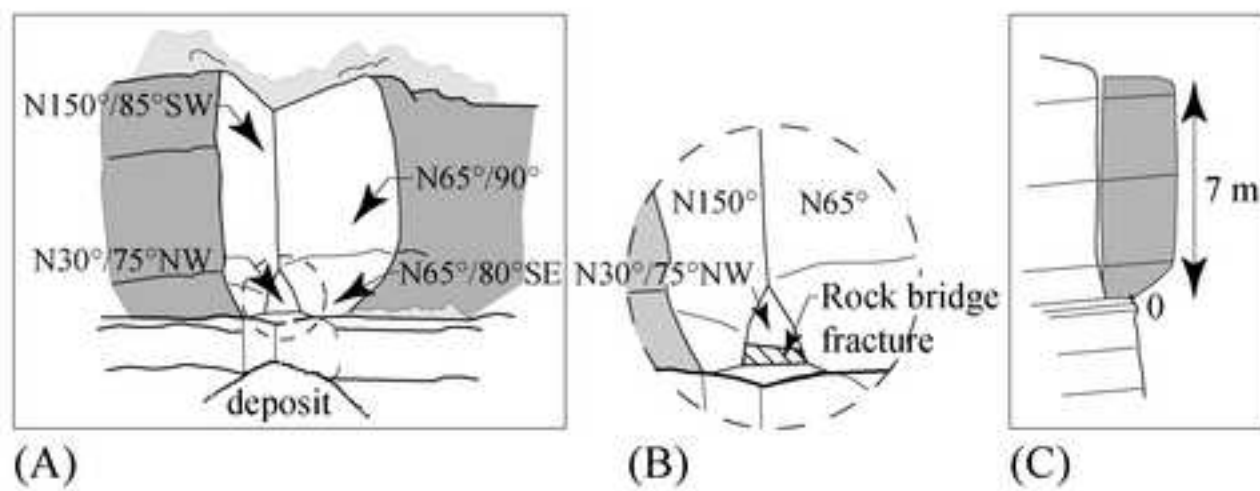
Figure 13

Fig. 13. (A) Sketch of the scar of the Goule Blanche rock fall, (B) focus on the zone of the intact rock fracture and (C) cross-section of the cliff before failure

The Goule Blanche rock fall, with a volume of about 30 m<sup>3</sup>, occurred in the upper part of a 200 m high cliff, striking N30°, at an unknown date around the year 2000. Beds are horizontal and cut by two steeply dipping joint sets which strike N64° (J1) and N152° (J2). The failure surface is about 7 m high. It is made up first by a wedge defined by two surfaces N65°/80-90°SE and N150°/85-90°SW belonging respectively to sets J1 and J2 (Fig. 13A). These two surfaces are coated with a calcite crust. In the lower part of this wedge, there is a singular plane N30°/75°NW, which includes a fresh intact rock fracture surface (Fig. 13B). This fracture surface has an area of 0.2 m<sup>2</sup> (0.8 % of the scar area). The base of the block is made up of a horizontal bedding plane. The lower part of the fallen mass was overhanging, allowing for a toppling mechanism (Fig. 13C). According to the maximum work principle, the stress in the rock bridge was a pure shear stress (Fig. 12). With a friction angle of 30° for the base of the block, the failure criterion (Eq. 9) is fulfilled. The estimated in situ cohesion and tensile strength values are respectively 14 MPa and 4.2 MPa.
