Multiscale fracture analysis along the French chalk coastline for investigating erosion by cliff collapse

Albert Genter, Anne Duperret, A. Martinez, R.N. Mortimore, J.-L. Vila

Special issue: "Coastal chalk cliff instability"

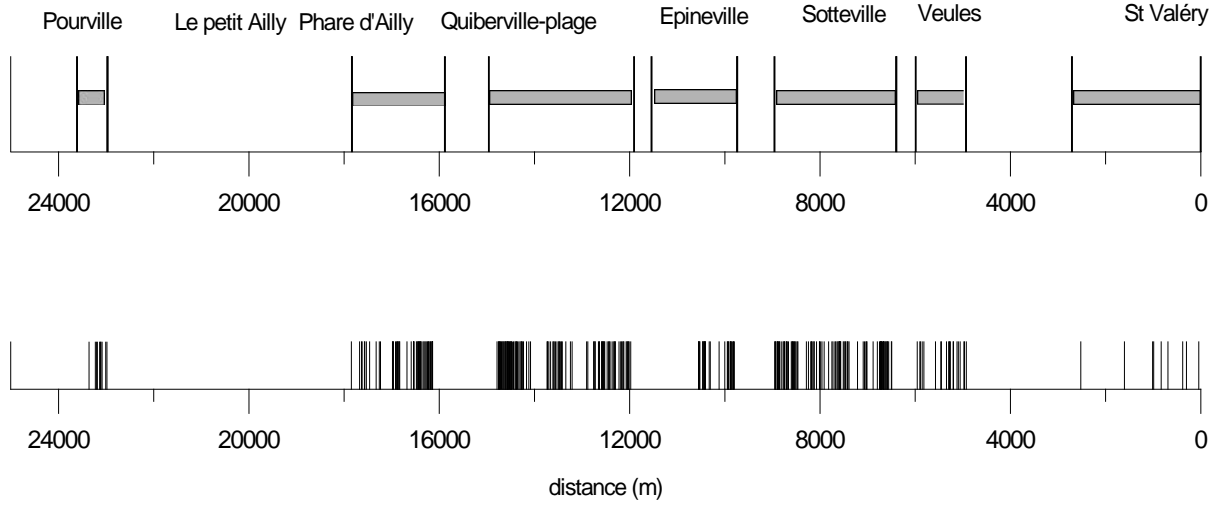
Fig. 5 : Location of the detailed coastal sections analysed on the field between St Valéry-en-Caux (SW) and Pourville (NE) and fracture location

Investigated zone during the field work

A continuous section between Pourville to St Valéry en Caux was investigated at field scale and compared with the cliff photo interpretation (Fig. 5). In this section of about 25 km long, all the pre-existing fractures visible in the field were classified, measured and located (Fig. 6). Three main types of fractures were observed in the field: (1) Normal faults characterized by a N120E orientation. Secondary fracture sets oriented N-S and E-W were present preferentially between Quiberville and

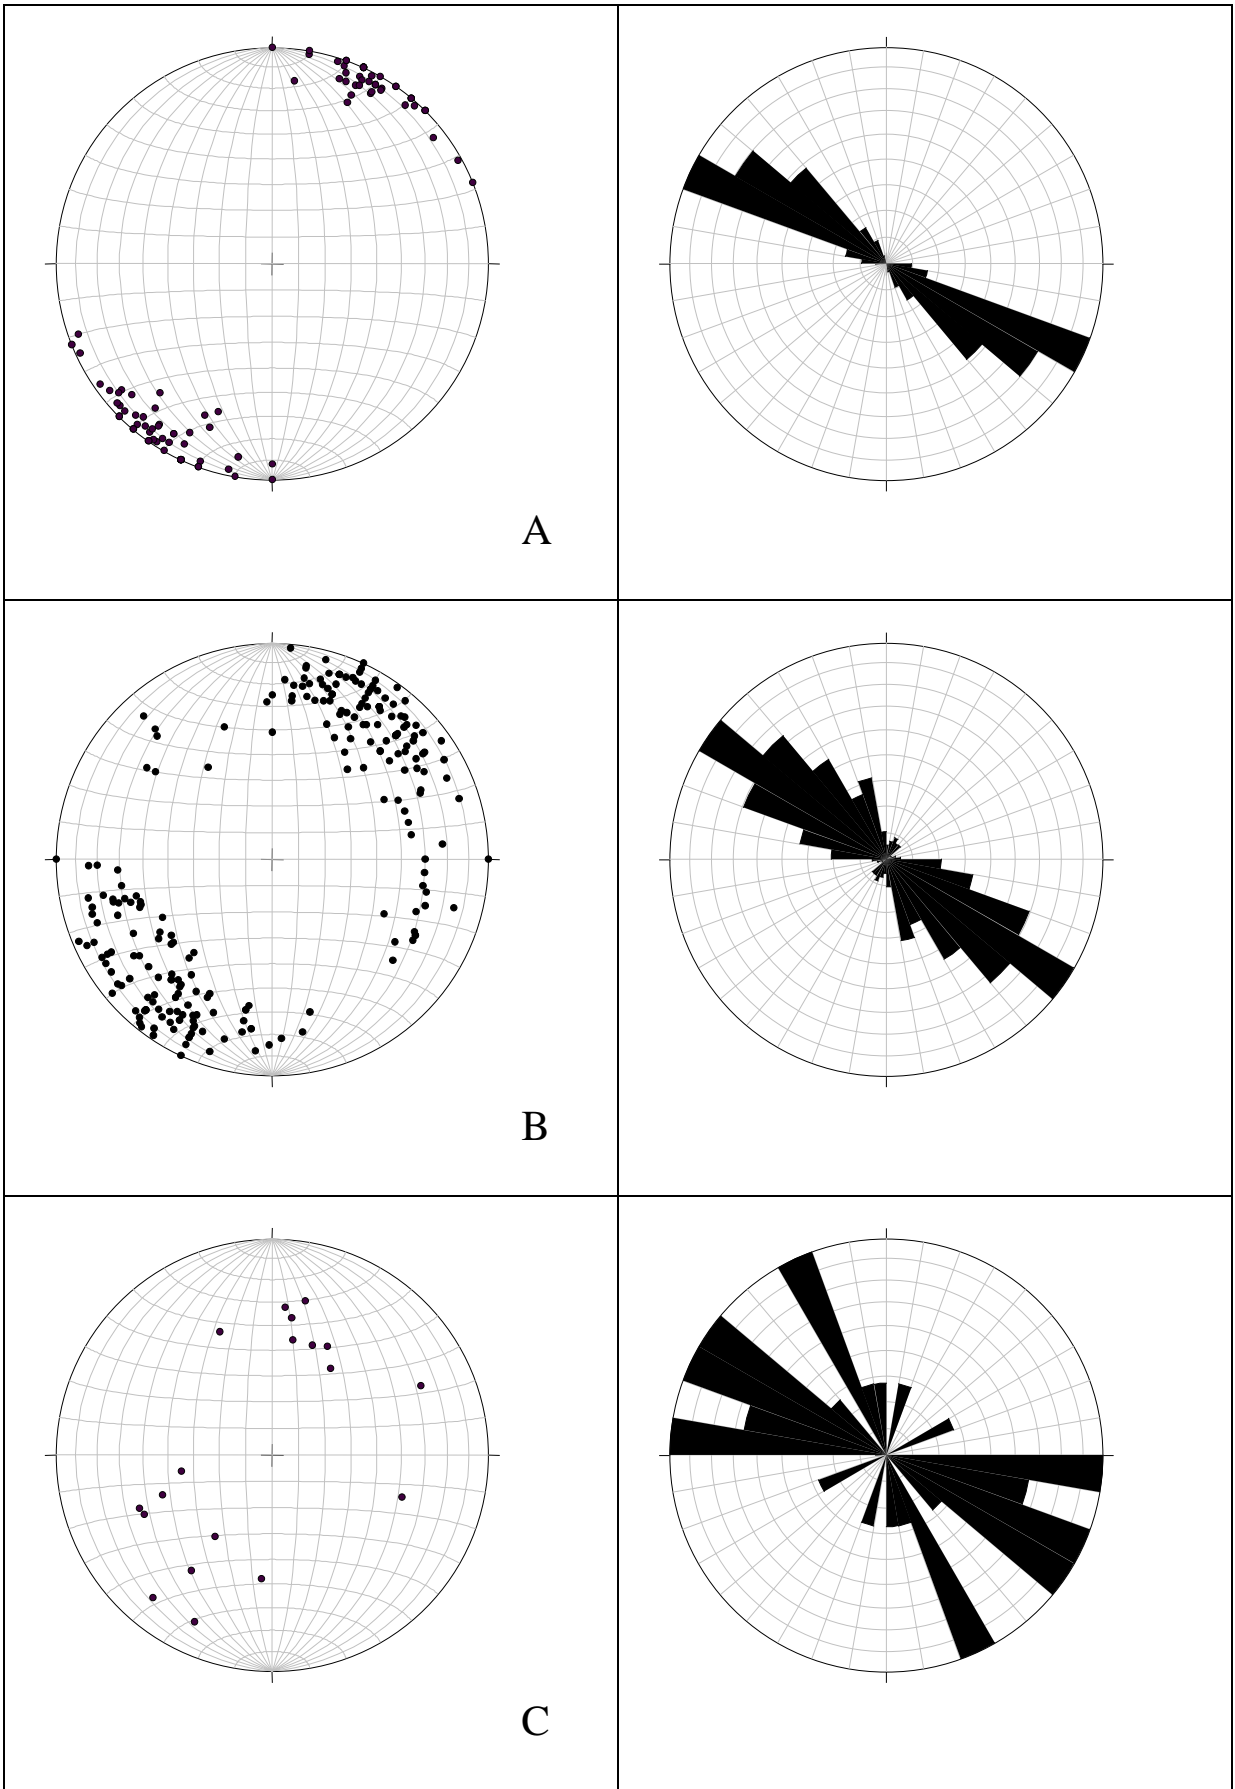
Fig. 6, Genter et al., 2002

Fig. 6 : Stereographical projections (Schmidt plot in lower hemisphere) of the fractures collected on the field between St Valéry-en-Caux and Pourville. A: master-joints, B: normal faults, C: synsedimentary fractures

St Aubin where they formed conjugate networks. In terms of size, they were mainly cross-cliff fractures but the N-S and E-W fault sets were small-scale normal faults. (2) Master-joints, characterized by a dominant N110-120E orientation, were large-scale steeply dipping fractures. (3) Synsedimentary faults, which are quite isolated, showed oblique dip values ranging between 50 and 70° and E-W to NW-SE orientations. These last small-scale to medium scale fractures were mainly filled by black flint.
