# Contact surface topography and system dynamics of brake squeal

Francesco Massi <sup>a,\*</sup>, Yves Berthier <sup>a</sup>, Laurent Baillet <sup>b</sup>

Brake noise is an example of noise caused by vibrations induced by friction forces. During brake operation, the friction between the pad and the disc can induce a dynamic instability in the system. Brake squeal can occur in the frequency range between 1 and 20 kHz, and more. Approaches to this problem are usually confined to the analysis of the system dynamics or to the tribological studies (analysis of the contact surfaces). In a previous dynamic analysis, the squeal events treated in this paper were identified to be dynamic instabilities of the brake system. This paper presents an experimental tribological analysis performed in parallel to the dynamic one and aimed to highlight the role of the contact problems in the squeal phenomena. The topography of the contact surface after braking phase with and without squeal is presented. The features of the third body and the surface topography were found to be completely different in the two cases. After squeal events the topography of the surface and the internal structure of the pa

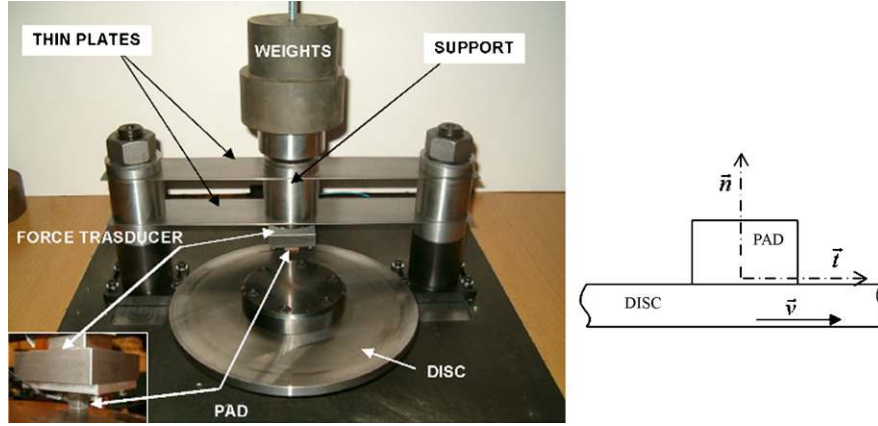
**Fig. 1.** Left: experimental set-up, TriboBrake COLRIS (Collaboration Lyon-Rome for Investigation on Squeal). Right: schema of the contact.

pad pushed against the disc by weights positioned on a floating support (Fig. 1).

The support (central cylindrical body in Fig. 1) is also made of steel and its shape is chosen to simplify its dynamic behaviour. The normal force between pad and disc (braking pressure) can be adjusted, by adding weights on top of the support, between 25 and 225 N. Introducing normal load with weights placed upon the pad support, that is not constrained in the vertical direction, allows the pad surface to follow the disc oscillations, due to its not perfect planarity, and assures a constant average value of the contact force. Two thin plates hold the pad support in the tangential (sliding) direction. The breakings have been performed at a constant velocity of 10 rpm.

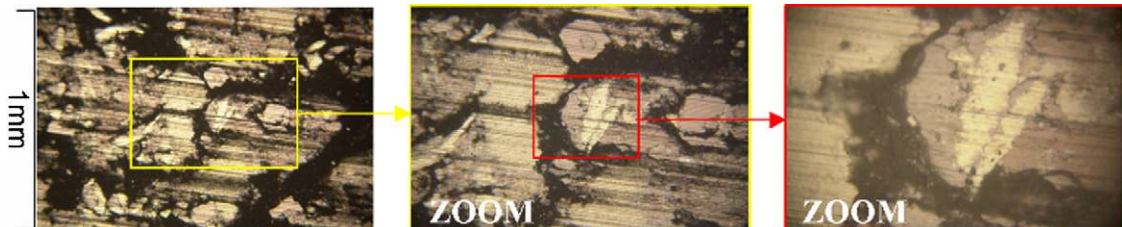
**Fig. 2.** Three consecutive zooms of the pad contact surface characterized by contact plateaus.  $V_s$  is the sliding velocity.

The exact formulation of the friction material is unknown. Moreover, as the pad gradually is worn off, the different wear rates of the different components cause a different material composition at the contact surface. In particular, particles and fibers with high wear resistance (e.g., structural materials) resist better than the neighbouring material and form areas of high contact pressure.

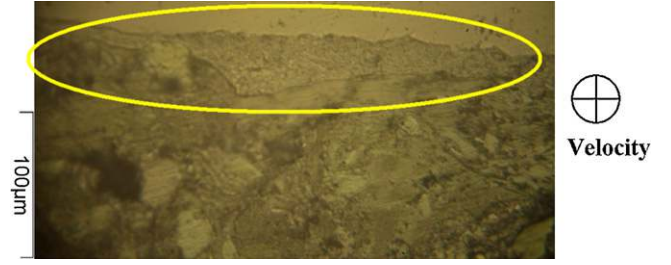
Fig. 3. Layer of third body accommodating the pad and disc contact surfaces.

Fig. 3 shows a section of the contact surface perpendicular to the sliding direction. After treatment with resin, preventing loose wear particles from being removed from the surface, the pad is cut in a plane normal to the sliding velocity to highlight the third body layer after brake events. A layer (about 10  $\mu\text{m}$ ) of third body accommodates the pad and disc profiles and forms the contact surface. The same situation is observed at all the contact areas; the areas in contact are constituted or by contact plateau of third body, or by structural fibers in contact with the disc surface and surrounded by third body. A layer of third body is always found between the disc and pad surface, as showed by the SEM analysis in the following. The parallel grooves due to the disc surface are recognizable on the top of the layer of third body, where the contact takes place. The analysis underlines the importance of the third body in the contact topography between pad and disc.

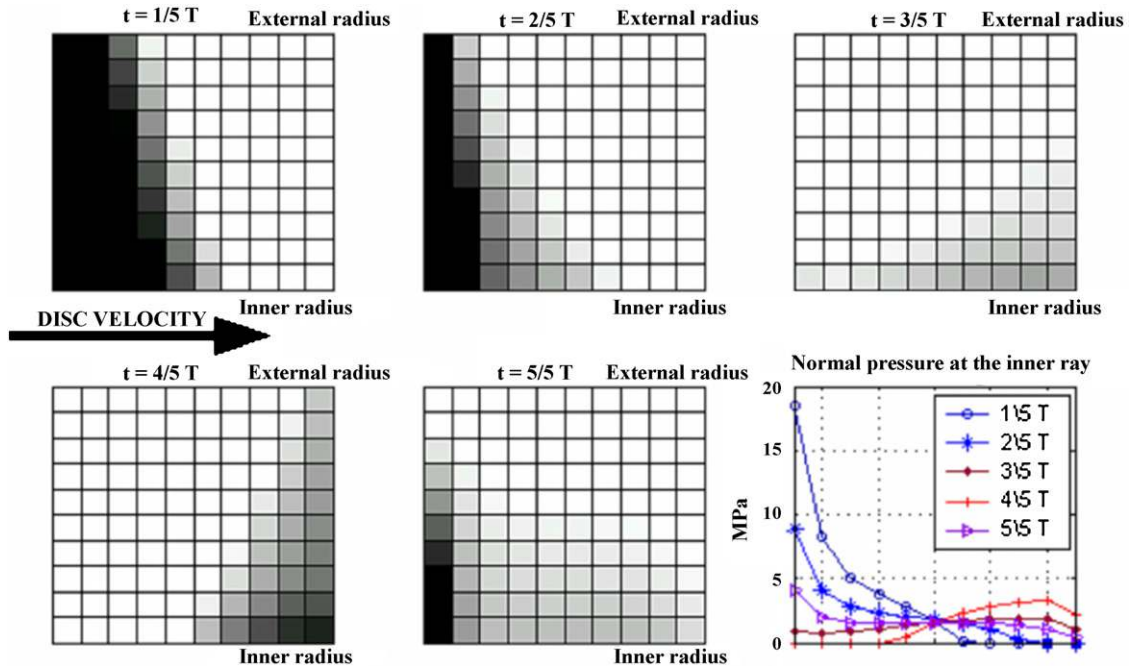
Fig. 4. Contact normal pressure distribution calculated at the pad surface (10 mm  $\times$  10 mm) by FEM, for five time steps  $t$  along the squeal period  $T = 2.9e-4$ . The average pressure is  $\bar{\sigma}_n = 1$  MPa.

surface and the largest values are calculated at the leading edge, along the inner radius. In fact, because of the tangential deformation of the support under the friction torque (due to the friction force and the constraint at the connection with the thin plates), the contact stresses are the highest at the leading edge of the pad surface. The largest value of the contact stresses at the inner radius is due to the bending (static) deformation of the disc under the normal load.

pressure: Fig. 4 shows the local contact pressure ( $\sigma_n$ ) calculated by FEM at five different time steps during the temporal braking simulation in squeal conditions ( $\omega_{\text{disc}} = 100 \text{ rpm}$ ,  $\bar{v}_r = 0.02 \text{ m/s}$ ,  $\mu = 0.5$ , global normal force  $N = 100 \text{ N}$ , mean contact pressure  $\bar{\sigma}_n = 1 \text{ MPa}$ ). The time steps are chosen to cover the period of vibration. The white area indicates the local detachment ( $\sigma_n = 0$ ) between pad and disc surface. The black area corresponds to the maximum of the contact pressure. As in the previous case, the highest peak of oscillation is located at the leading edge and the larger contact stresses are located at the inner radius. The last graphic in Fig. 4 shows the pressure distribution at the inner radius corresponding to the five time steps. Again, because of the tangential vibrations of the pad surface, the relative sliding velocity between the pad and the disc oscillates at the squeal frequency around the average sliding velocity  $\bar{v}_r$  due to the disc rotation. The local impacts and local relative slidings at high velocity and high frequency cause much higher local normal and tangential stresses [26]; these oscillations at high frequency (squeal frequency) of the local stresses involve the first layer of the material at the contact surface.

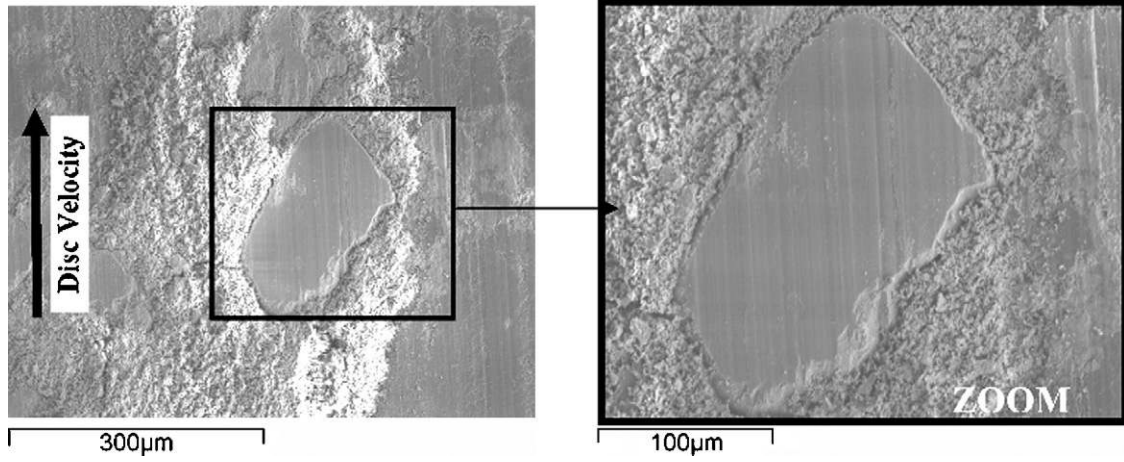
Fig. 5. Contact plateau due to the hard material fiber at the contact surface.

A preliminary analysis of the contact surface of the pad after a braking phase without squeal is carried out by the SEM (Scanning Electron Microscope). After a consistent braking period (about 100 min at 10 rpm) the whole pad surface is worn and the pad is in full contact with the disc. Nevertheless, the real contact area is localized at the contact plateaus. Fig. 5 shows a contact plateau formed around a structural fiber that is composed by hard material. It is characterized by a compact smooth area with small parallel grooves along the sliding direction that are determined by the sliding with the disc. The plateau is surrounded by a no-contact area where the material has been worn off.

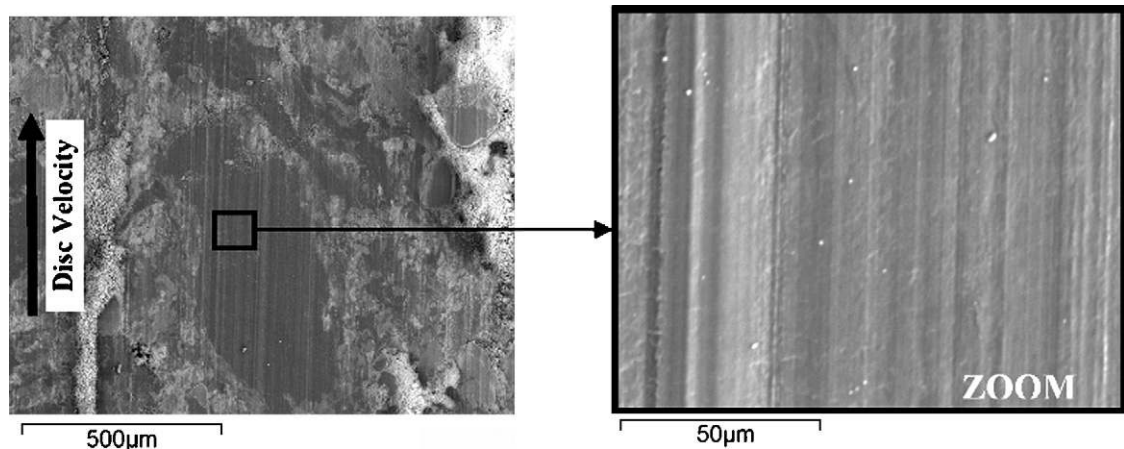
Fig. 6. Contact plateau due to the third body accumulated over the soft pad components (no fibers in the contact area). The third body is compact.

Fig. 6 shows a contact plateau where structural fibers do not compare. The contact plateau is constituted by a smooth layer of third body.

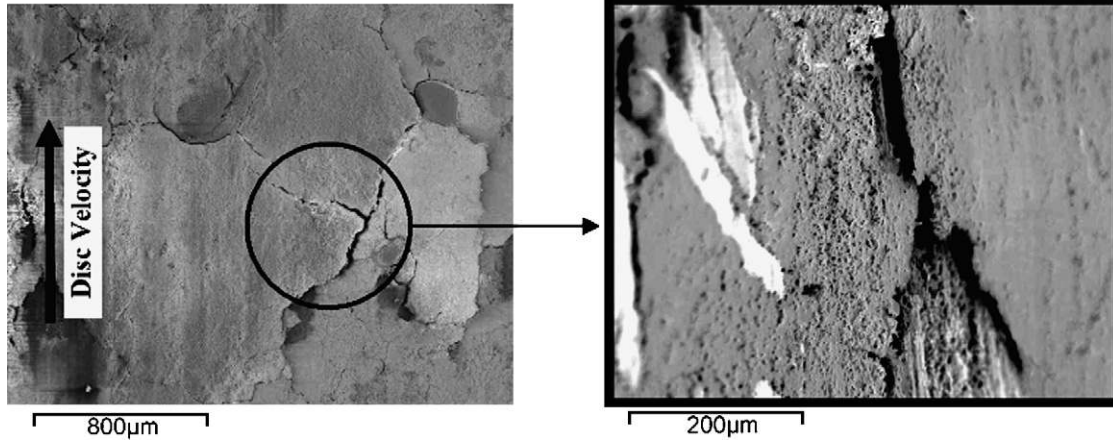
Fig. 7. Material exfoliations at the pad contact surface after squeal.

Figs. 7 and 8 show a material exfoliation at different scales. Fig. 7 shows a material exfoliation covering an area larger than 1 mm<sup>2</sup>; while Fig. 8 shows a contact plateau where the dimensions of the

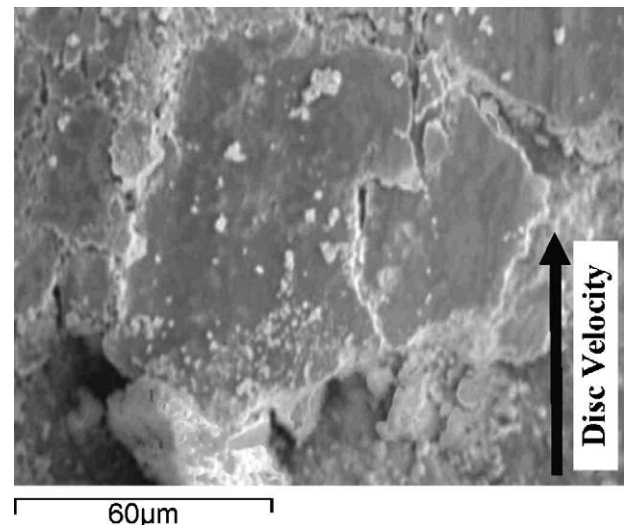
Fig. 8. Micro-exfoliation of the third body (contact plateaus) after squeal.

exfoliations are of some μm<sup>2</sup>. Most of the contact plateaus on the pad surface are characterized by a no compact third body.

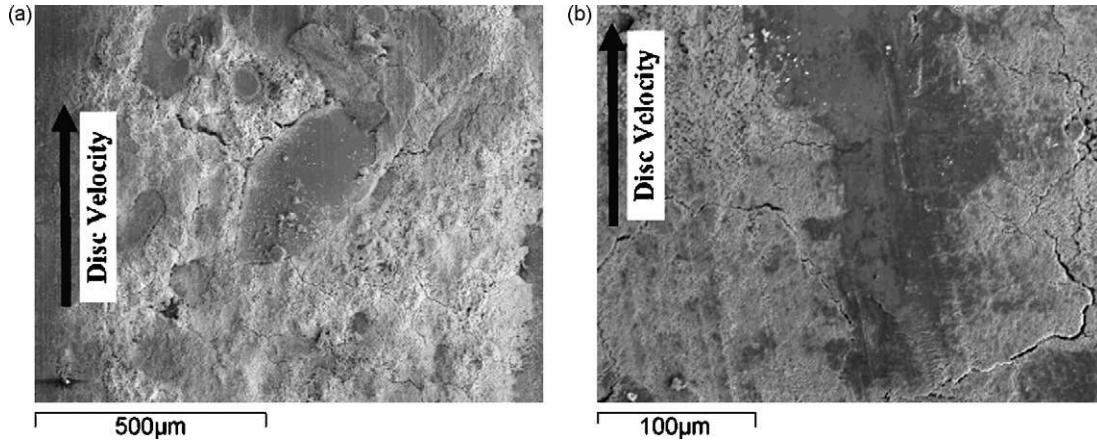
Fig. 9. Superficial cracks both at the no-contact area (a) and at the contact plateaus (b), after squeal.

Fig. 9a shows a contact plateau due to a superficial fiber with the surrounding no-contact area. The pad surface around the fiber is characterized by several cracks. Same results are shown in Fig. 9b where a contact plateau of soft material is interested by the cracks, together with the surrounding no-contact zone (note that the scales in Fig. 9 are different). The whole pad surface is characterized by superficial cracks or material exfoliations. Cracks can nucleate either in proximity of structural fibers or not.

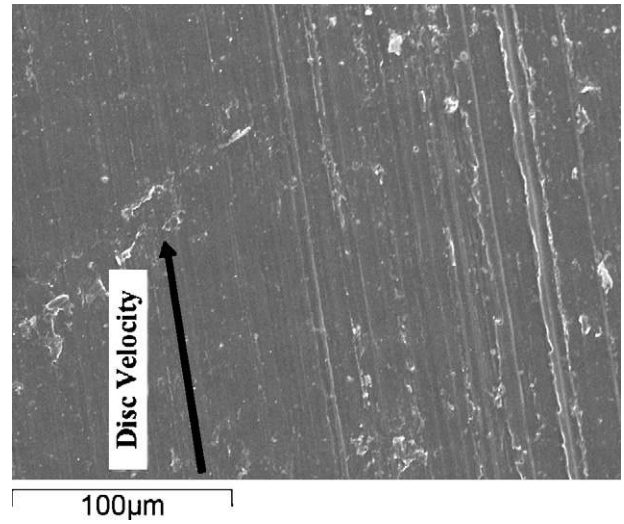
Fig. 10. Disc contact surface; circumferential grooves due to the sliding with the pad.

Nevertheless, after a large number of runs, the starting roughness is worn up, and the disc surface is characterized by concentric circular grooves along the sliding direction (Fig. 10). The grooves are formed because of the plastic deformation of the disc material that can be ascribed either to the contact with the hardest points (structural fibers) of the pad surface or to the local high pressure due to the third body. During this stage the squeal amplitude is constant with the disc rotation.

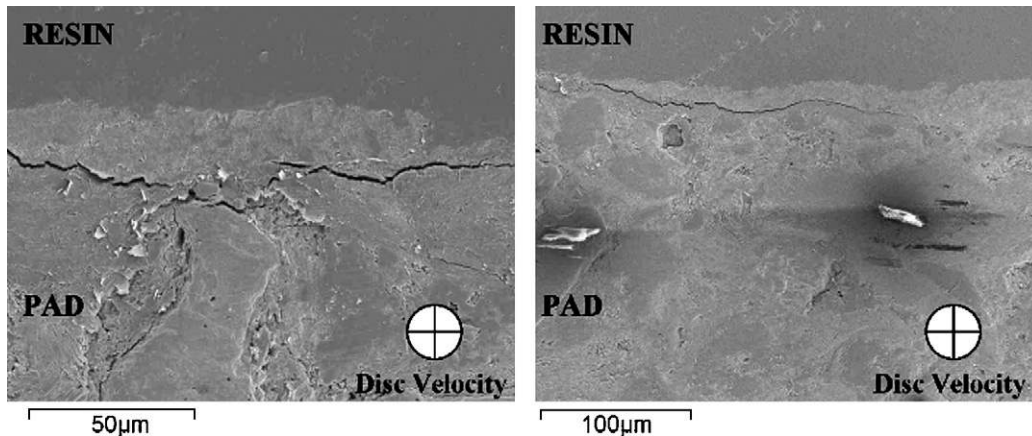
Fig. 11. Section of the pad contact surface normal to the sliding direction, highlighting detachments of the third body layers after squeal.

Fig. 11 shows two cases where the third body layer is detached from the pad material. Such detachments can be ascribed to the squeal vibrations, because the interface between pad and third body is weak. These superficial detachments correspond to the

exfoliations visible in the pad topography before the cut of the sample, and are not observed in samples without squeal.

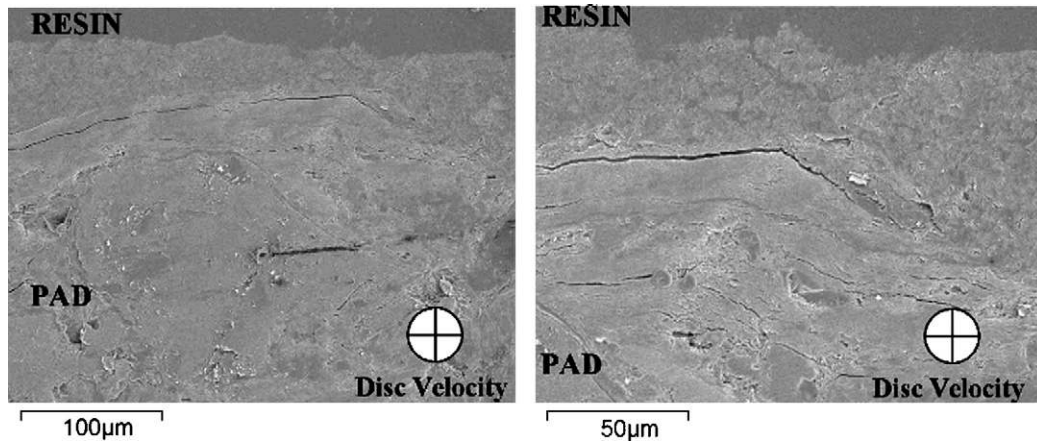
**Fig. 12.** Detachments of layers of pad material under the third body, after squeal.

Fig. 12 shows further superficial detachments. In this case the detachment does not happen between the pad and the third body,

but a thin layer of pad material detaches together with the third body layer. Thus, a crack parallel to the pad surface develops under the layer of third body, inside the pad material.

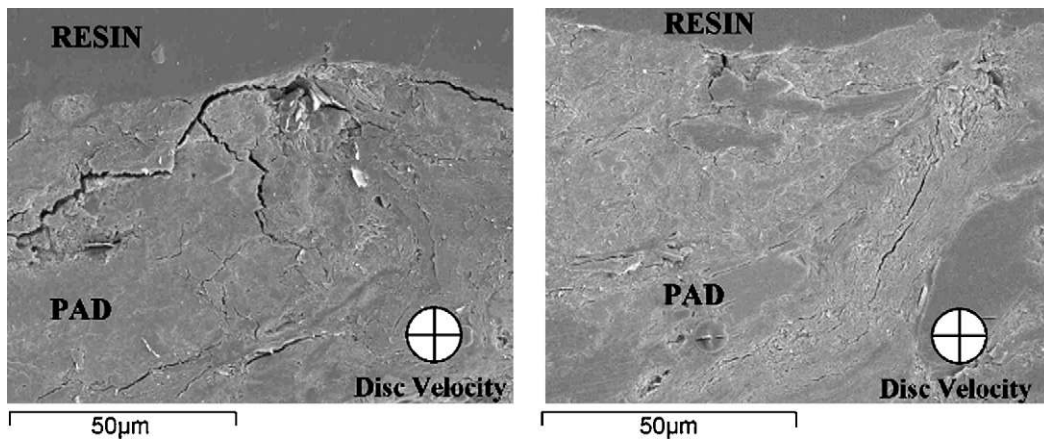
**Fig. 13.** Superficial cracks develop inside the pad material, after squeal.

Moreover, the cracks do not involve only the surface of the pad and the detachments due to the third body layer. Starting from the contact surface several cracks develop inside the pad material up to a depth of about 10  $\mu\text{m}$ . Fig. 13 shows two examples.

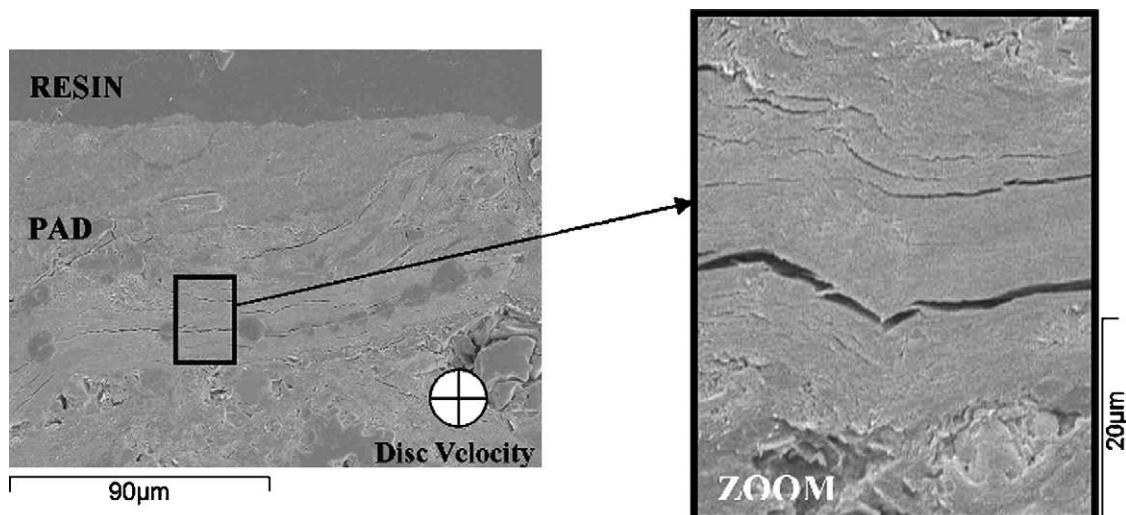
**Fig. 14.** Internal cracks close to the pad surface developing along layers of pad composites.

The material cracks can also nucleate inside the volume of the pad, close to the contact surface (Fig. 14). In the first layer of pad material (about 400  $\mu\text{m}$  from the contact surface) several cracks are observed without any preferential direction. The cracks follow the material composition by developing along areas filled by the same material component. This component expands throughout all the volume of the pad and the cracks develop along the direction of the continuous layers made of such component.
