Contact surface topography and system dynamics of brake squeal

Francesco Massi, Yves Berthier, Laurent Baillet

Francesco Massi, Yves Berthier, Laurent Baillet. Contact surface topography and system dynamics of brake squeal. *Wear*, 2008, 265 (11-12), pp.1784-1792. 10.1016/j.wear.2008.04.049 . insu-00355117

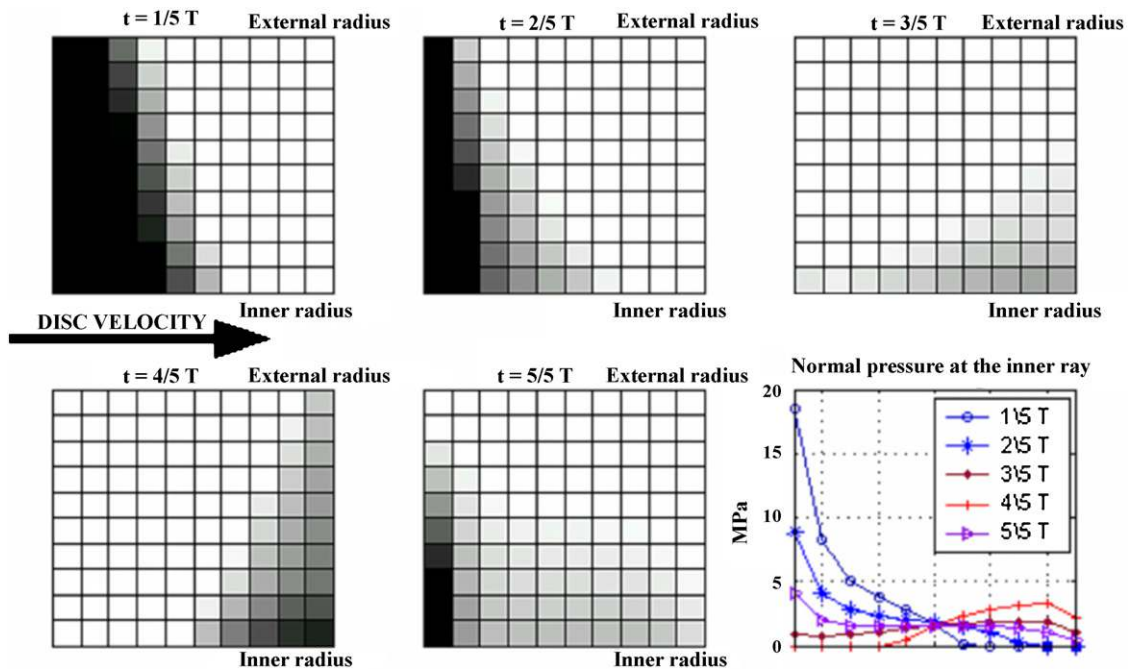
Fig. 4. Contact normal pressure distribution calculated at the pad surface (10 mm × 10 mm) by FEM, for five time steps t along the squeal period $T = 2.9e-4$. The average pressure is $\bar{\sigma}_n = 1$ MPa.

pressure: Fig. 4 shows the local contact pressure (σ_n) calculated by FEM at five different time steps during the temporal braking simulation in squeal conditions ($\omega_{\text{disc}} = 100$ rpm, $\bar{v}_r = 0.02$ m/s, $\mu = 0.5$, global normal force $N = 100$ N, mean contact pressure $\bar{\sigma}_n = 1$ MPa). The time steps are chosen to cover the period of vibration. The white area indicates the local detachment ($\sigma_n = 0$) between pad and disc surface. The black area corresponds to the maximum of the contact pressure. As in the previous case, the highest peak of oscillation is located at the leading edge and the larger contact stresses are located at the inner radius. The last graphic in Fig. 4 shows the pressure distribution at the inner radius corresponding to the five time steps. Again, because of the tangential vibrations of the pad surface, the relative sliding velocity between the pad and the disc oscillates at the squeal frequency around the average sliding velocity \bar{v}_r due to the disc rotation. The local impacts and local relative slidings at high velocity and high frequency cause much higher local normal and tangential stresses [26]; these oscillations at high frequency (squeal frequency) of the local stresses involve the first layer of the material at the contact surface.

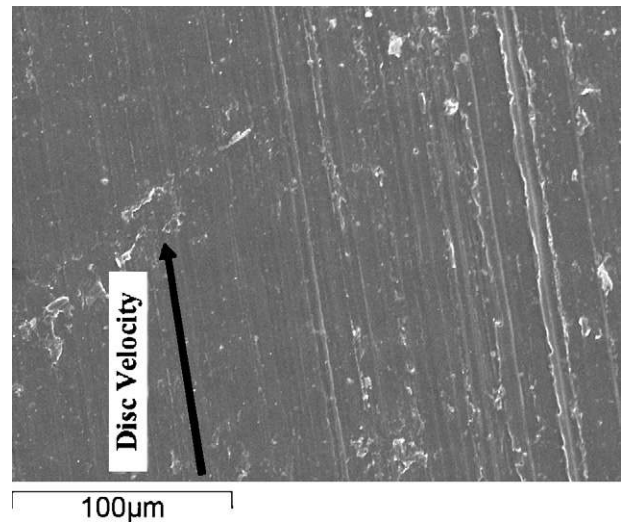
Fig. 10. Disc contact surface; circumferential grooves due to the sliding with the pad.

Nevertheless, after a large number of runs, the starting roughness is worn up, and the disc surface is characterized by concentric circular grooves along the sliding direction (Fig. 10). The grooves are formed because of the plastic deformation of the disc material that can be ascribed either to the contact with the hardest points (structural fibers) of the pad surface or to the local high pressure due to the third body. During this stage the squeal amplitude is constant with the disc rotation.

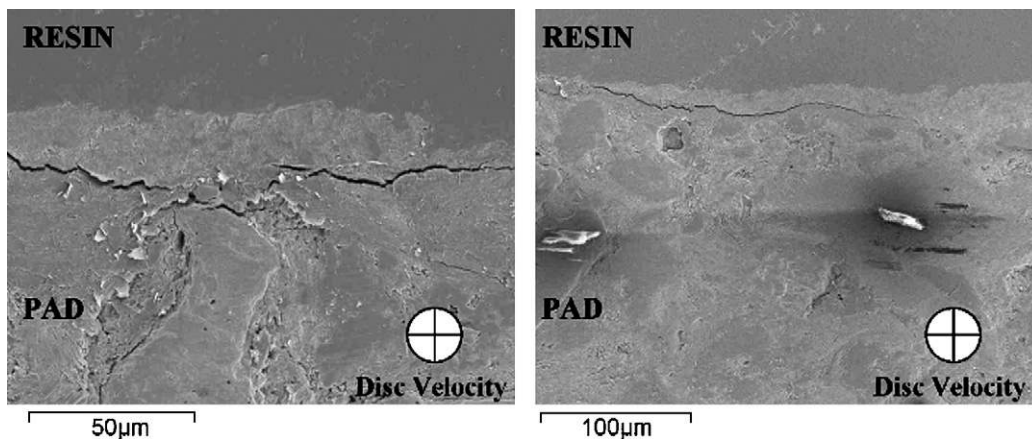
Fig. 11. Section of the pad contact surface normal to the sliding direction, highlighting detachments of the third body layers after squeal.

Fig. 11 shows two cases where the third body layer is detached from the pad material. Such detachments can be ascribed to the squeal vibrations, because the interface between pad and third body is weak. These superficial detachments correspond to the

exfoliations visible in the pad topography before the cut of the sample, and are not observed in samples without squeal.

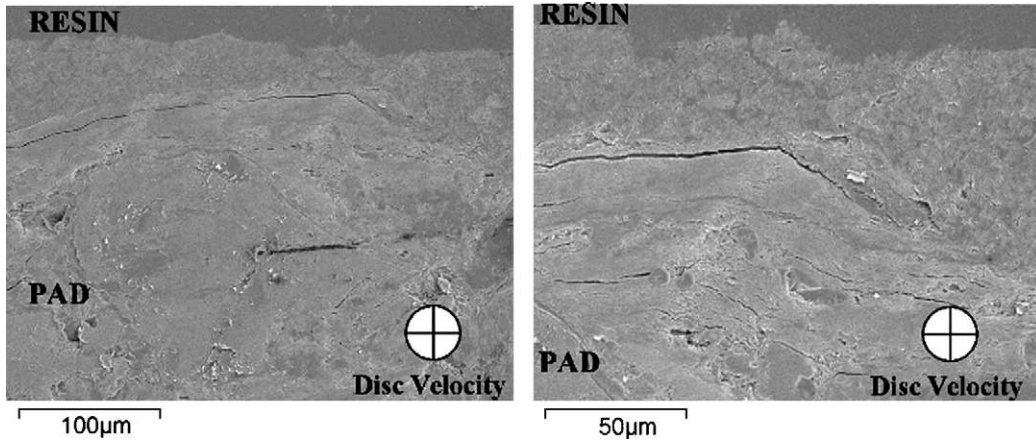
Fig. 12. Detachments of layers of pad material under the third body, after squeal.

Fig. 12 shows further superficial detachments. In this case the detachment does not happen between the pad and the third body,

but a thin layer of pad material detaches together with the third body layer. Thus, a crack parallel to the pad surface develops under the layer of third body, inside the pad material.

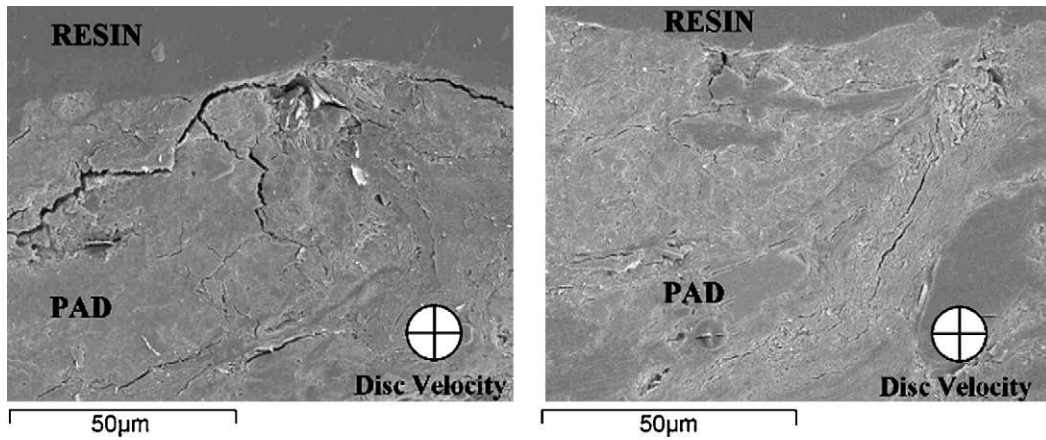
Fig. 13. Superficial cracks develop inside the pad material, after squeal.

Moreover, the cracks do not involve only the surface of the pad and the detachments due to the third body layer. Starting from the contact surface several cracks develop inside the pad material up to a depth of about 10 μm . Fig. 13 shows two examples.

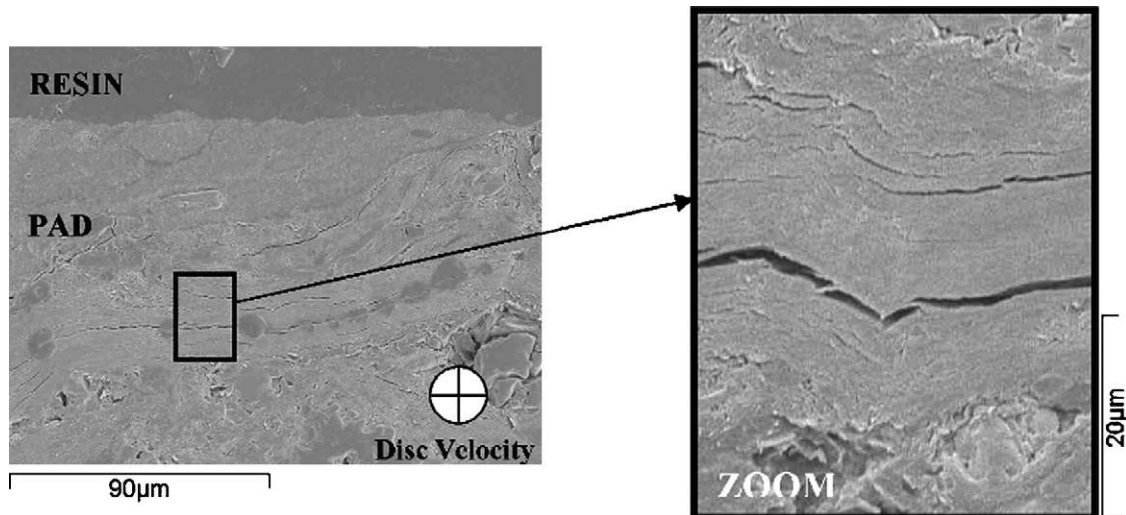
Fig. 14. Internal cracks close to the pad surface developing along layers of pad composites.

The material cracks can also nucleate inside the volume of the pad, close to the contact surface (Fig. 14). In the first layer of pad material (about 400 μm from the contact surface) several cracks are observed without any preferential direction. The cracks follow the material composition by developing along areas filled by the same material component. This component expands throughout all the volume of the pad and the cracks develop along the direction of the continuous layers made of such component.
