Contact surface topography and system dynamics of brake squeal

Francesco Massi ^{a,*}, Yves Berthier ^a, Laurent Baillet ^b

Brake noise is an example of noise caused by vibrations induced by friction forces. During brake operation, the friction between the pad and the disc can induce a dynamic instability in the system. Brake squeal can occur in the frequency range between 1 and 20 kHz, and more. Approaches to this problem are usually confined to the analysis of the system dynamics or to the tribological studies (analysis of the contact surfaces). In a previous dynamic analysis, the squeal events treated in this paper were identified to be dynamic instabilities of the brake system. This paper presents an experimental tribological analysis performed in parallel to the dynamic one and aimed to highlight the role of the contact problems in the squeal phenomena. The topography of the contact surface after braking phase with and without squeal is presented. The features of the third body and the surface topography were found to be completely different in the two cases. After squeal events the topography of the surface and the internal structure of the pad material close to the contact

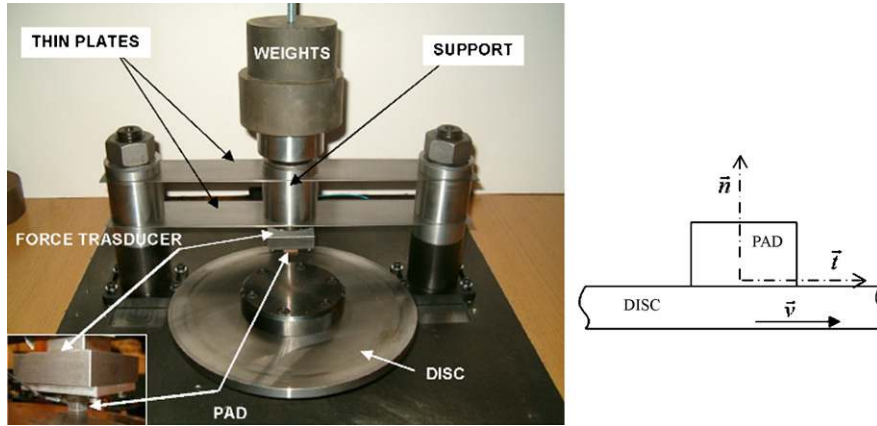
Fig. 1. Left: experimental set-up, TriboBrake COLRIS (Collaboration Lyon-Rome for Investigation on Squeal). Right: schema of the contact.

pad pushed against the disc by weights positioned on a floating support (Fig. 1).

The support (central cylindrical body in Fig. 1) is also made of steel and its shape is chosen to simplify its dynamic behaviour. The normal force between pad and disc (braking pressure) can be adjusted, by adding weights on top of the support, between 25 and 225 N. Introducing normal load with weights placed upon the pad support, that is not constrained in the vertical direction, allows the pad surface to follow the disc oscillations, due to its not perfect planarity, and assures a constant average value of the contact force. Two thin plates hold the pad support in the tangential (sliding) direction. The breakings have been performed at a constant velocity of 10 rpm.

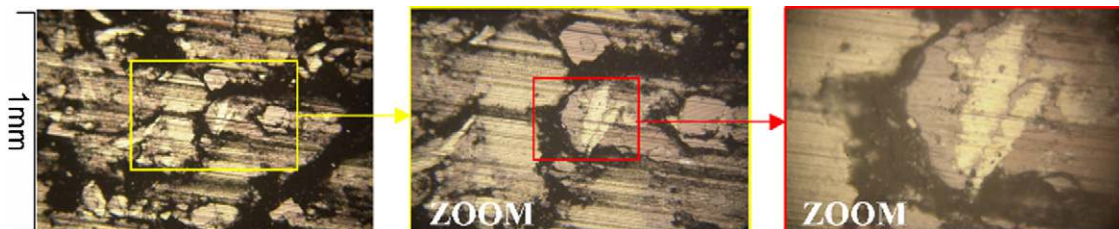
Fig. 2. Three consecutive zooms of the pad contact surface characterized by contact plateaus. V_s is the sliding velocity.

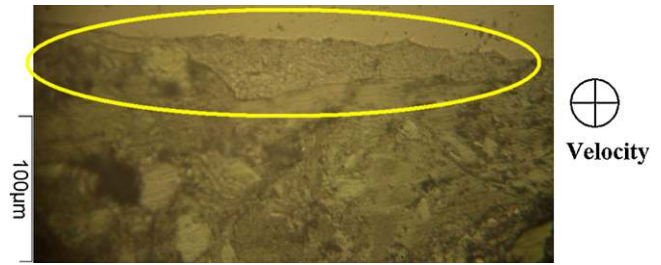
Fig. 3. Layer of third body accommodating the pad and disc contact surfaces.

Fig. 3 shows a section of the contact surface perpendicular to the sliding direction. After treatment with resin, preventing loose wear particles from being removed from the surface, the pad is cut in a plane normal to the sliding velocity to highlight the third body layer after brake events. A layer (about 10 μm) of third body accommodates the pad and disc profiles and forms the contact surface. The same situation is observed at all the contact areas; the areas in contact are constituted or by contact plateau of third body, or by structural fibers in contact with the disc surface and surrounded by third body. A layer of third body is always found between the disc and pad surface, as showed by the SEM analysis in the following. The parallel grooves due to the disc surface are recognizable on the top of the layer of third body, where the contact takes place. The analysis underlines the importance of the third body in the contact topography between pad and disc.

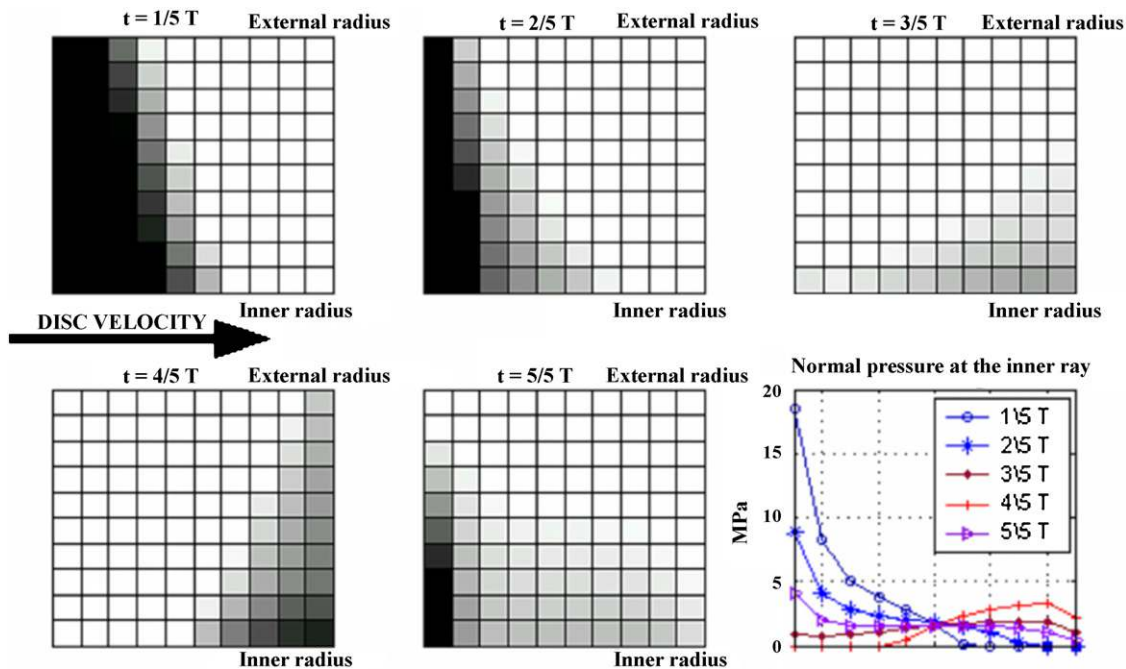
Fig. 4. Contact normal pressure distribution calculated at the pad surface (10 mm × 10 mm) by FEM, for five time steps t along the squeal period $T = 2.9e-4$. The average pressure is $\bar{\sigma}_n = 1$ MPa.

pressure: Fig. 4 shows the local contact pressure (σ_n) calculated by FEM at five different time steps during the temporal braking simulation in squeal conditions ($\omega_{disc} = 100$ rpm, $\bar{v}_r = 0.02$ m/s, $\mu = 0.5$, global normal force $N = 100$ N, mean contact pressure $\bar{\sigma}_n = 1$ MPa). The time steps are chosen to cover the period of vibration. The white area indicates the local detachment ($\sigma_n = 0$) between pad and disc surface. The black area corresponds to the maximum of the contact pressure. As in the previous case, the highest peak of oscillation is located at the leading edge and the larger contact stresses are located at the inner radius. The last graphic in Fig. 4 shows the pressure distribution at the inner radius corresponding to the five time steps. Again, because of the tangential vibrations of the pad surface, the relative sliding velocity between the pad and the disc oscillates at the squeal frequency around the average sliding velocity \bar{v}_r due to the disc rotation. The local impacts and local relative slidings at high velocity and high frequency cause much higher local normal and tangential stresses [26]; these oscillations at high frequency (squeal frequency) of the local stresses involve the first layer of the material at the contact surface.

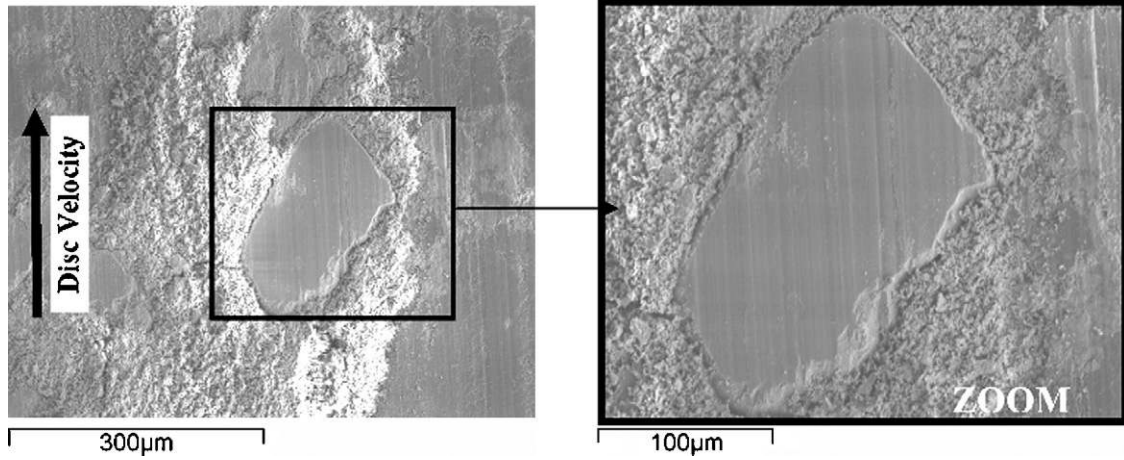
Fig. 5. Contact plateau due to the hard material fiber at the contact surface.

A preliminary analysis of the contact surface of the pad after a braking phase without squeal is carried out by the SEM (Scanning Electron Microscope). After a consistent braking period (about 100 min at 10 rpm) the whole pad surface is worn and the pad is in full contact with the disc. Nevertheless, the real contact area is localized at the contact plateaus. Fig. 5 shows a contact plateau formed around a structural fiber that is composed by hard material. It is characterized by a compact smooth area with small parallel grooves along the sliding direction that are determined by the sliding with the disc. The plateau is surrounded by a no-contact area where the material has been worn off.

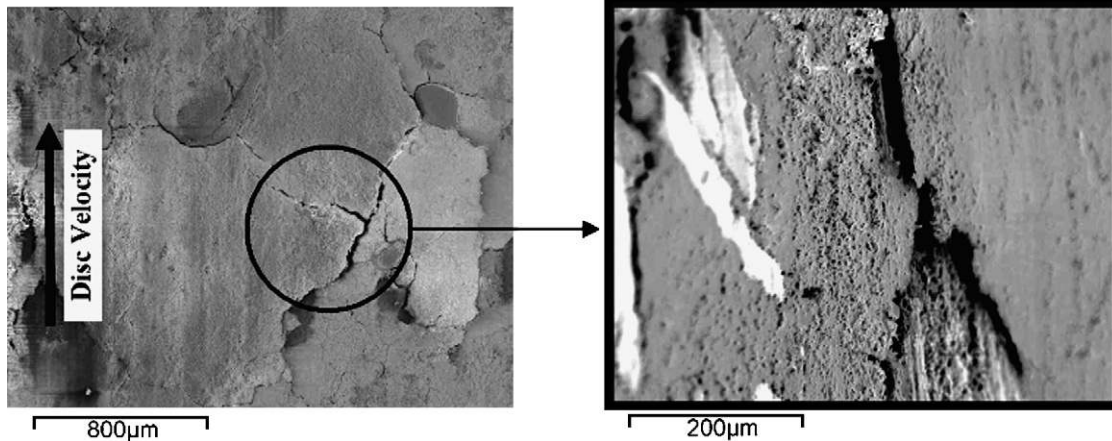
Fig. 7. Material exfoliations at the pad contact surface after squeal.

Figs. 7 and 8 show a material exfoliation at different scales. Fig. 7 shows a material exfoliation covering an area larger than 1 mm^2 ; while Fig. 8 shows a contact plateau where the dimensions of the

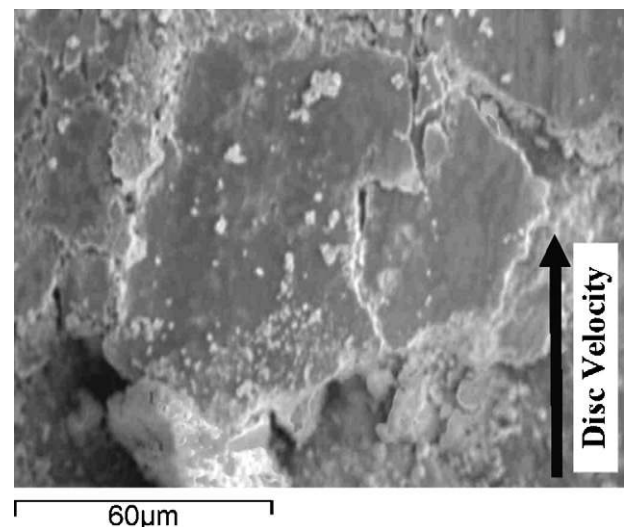
exfoliations are of some μm^2 . Most of the contact plateaus on the pad surface are characterized by a no compact third body.

Fig. 8. Micro-exfoliation of the third body (contact plateaus) after squeal.

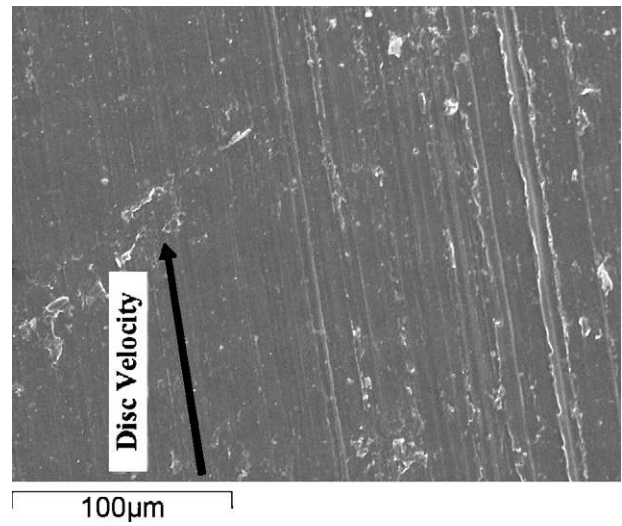
Nevertheless, after a large number of runs, the starting roughness is worn up, and the disc surface is characterized by concentric circular grooves along the sliding direction (Fig. 10). The grooves are formed because of the plastic deformation of the disc material that can be ascribed either to the contact with the hardest points (structural fibers) of the pad surface or to the local high pressure due to the third body. During this stage the squeal amplitude is constant with the disc rotation.

Fig. 10. Disc contact surface; circumferential grooves due to the sliding with the pad.

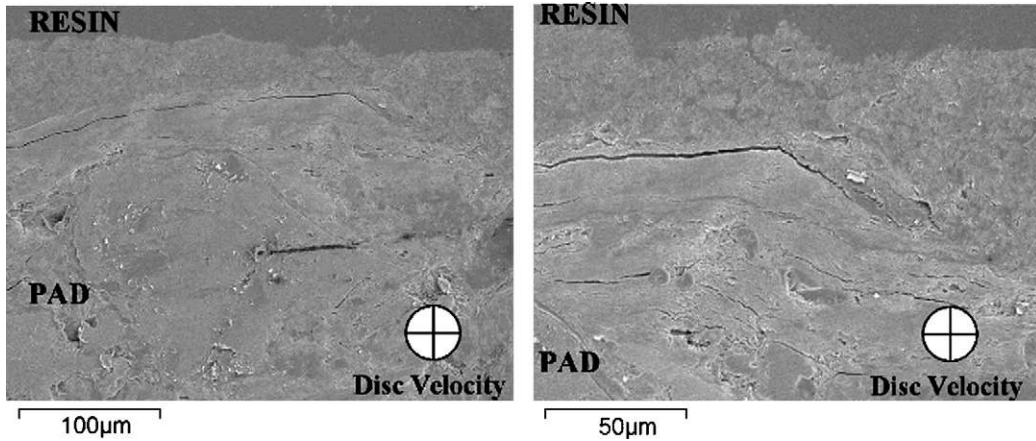
Fig. 12. Detachments of layers of pad material under the third body, after squeal.

Fig. 12 shows further superficial detachments. In this case the detachment does not happen between the pad and the third body,

but a thin layer of pad material detaches together with the third body layer. Thus, a crack parallel to the pad surface develops under the layer of third body, inside the pad material.

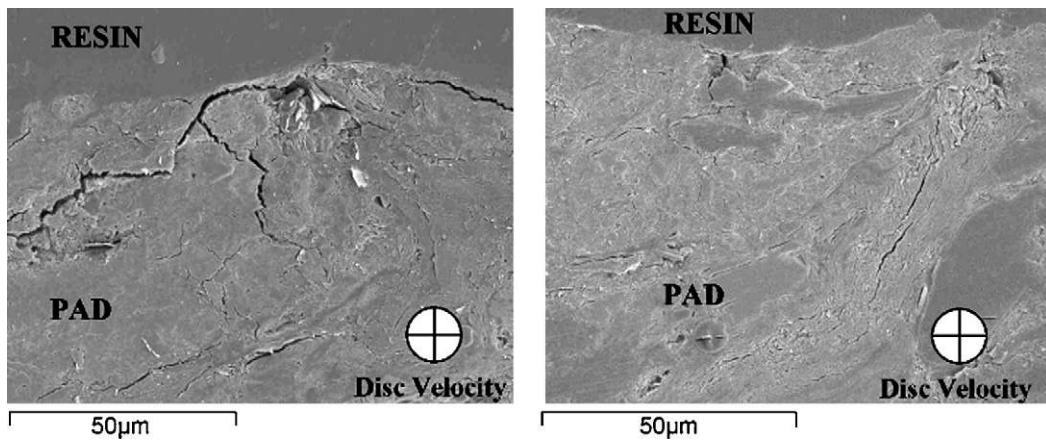
Fig. 13. Superficial cracks develop inside the pad material, after squeal.

Moreover, the cracks do not involve only the surface of the pad and the detachments due to the third body layer. Starting from the contact surface several cracks develop inside the pad material up to a depth of about 10 μm . Fig. 13 shows two examples.

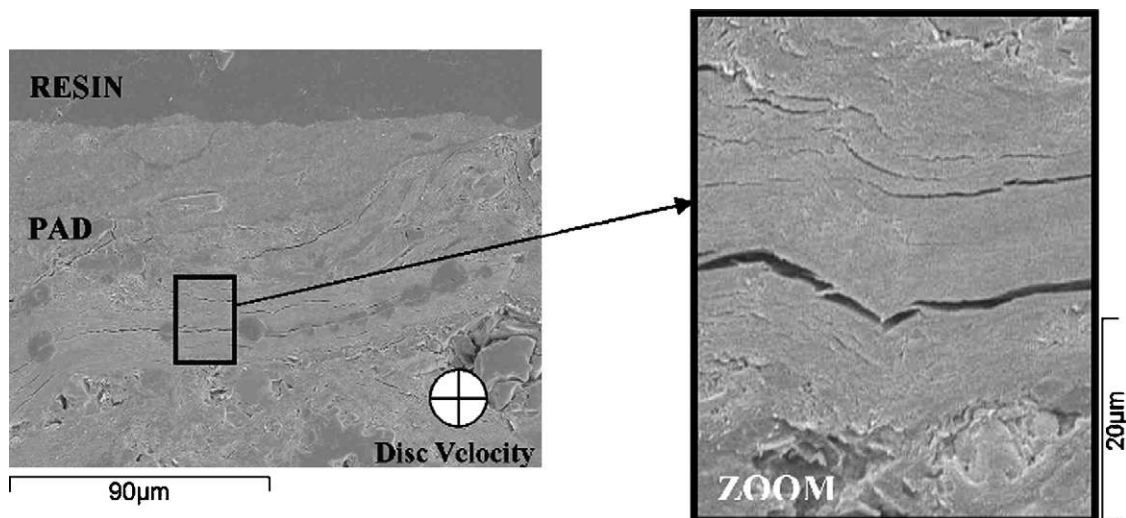
Fig. 14. Internal cracks close to the pad surface developing along layers of pad composites.

The material cracks can also nucleate inside the volume of the pad, close to the contact surface (Fig. 14). In the first layer of pad material (about 400 μm from the contact surface) several cracks are observed without any preferential direction. The cracks follow the material composition by developing along areas filled by the same material component. This component expands throughout all the volume of the pad and the cracks develop along the direction of the continuous layers made of such component.
