Experimental field study on the fatigue and failure mechanisms of coastal chalk cliffs: Implementation of a multi-parameter monitoring system (Sainte-Marguerite-sur-Mer, France)

PII: S0169-555X(22)00104-0

To appear in: *Geomorphology*

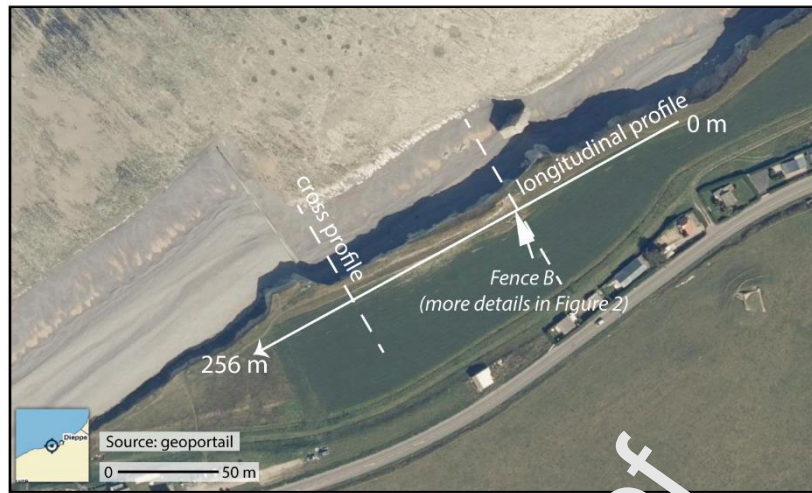
Figure 5: (a) Geophysical measurements location; (b) Ground Penetrating Radar (GPR) longitudinal profile (200 MHz, 12 m penetration depth); (c) Electrical Resistivity Tomography (ERT) longitudinal profile acquired on the cliff top, along the edge of the cliff, passing by

fence B (located in Figure 2). The common layer of investigated subsoil with GPR and ERT is delineated by the black dotted line. Note that the topography is enhanced in the GPR image; the depth scale differs compared with the ERT case.

The upper part of the chalk cliff is resistive enough to let electromagnetic waves propagate. The GPR depth of investigation is around 12 m (with an electromagnetic wave speed set at 1.3 m ns^{-1} , i.e. a dielectric constant of 5.3) and can be correlated with the resistivity pattern in the upper chalk layer. GPR signals between 60 and 200 m along the profile and down to a depth of 5 m reveal a heterogeneous chalk, probably resulting from open cracks filled with air and silt. Deeper (underneath the heterogeneous surface sub layer) and around this central area (at the extremities of the profile), radar signal strength has lower contrasts, indicating a homogeneous media compared with the wavelength (0.65 m) Figure 5b).

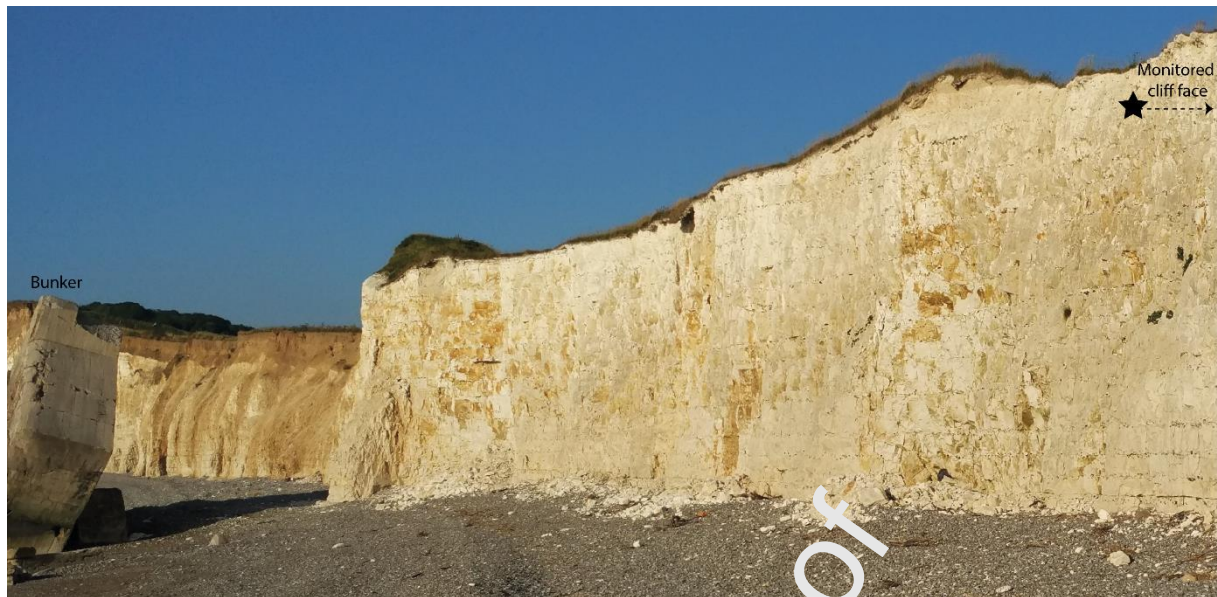
Figure 11: Rock falls and flakes observed in Sainte-Marguerite-sur-Mer (05/07/2018)

temperate climate (Aldred et al., 2016) and mid-latitude desert (McFadden et al., 2005; Eppes et al., 2015, 2010), cracks are preferentially observed in rock walls with northeast orientations. Insolation-related cracking is the main hypothesis, helped by other weathering processes at play (Aldred et al., 2016). A weathering mechanism that may be efficacious is the freeze/thaw cycles in the study site as they occur in a moisture-availability environment (Letavernier and Ozouf, 1987; Prick, 1995). Frost weathering leads to two processes: volumetric expansion and ice segregation (Matsuoka and Murton, 2008). As mentioned in Dewez et al. (2015), in Normandy, temperatures below 0°C (for fresh water) and below -2.5°C (for seawater) contract the rock while pore water freezes and dilates, leading to stress changes. These multidirectional strains accumulate and give rise to the breaking of pore walls and the appearance of micro-crack networks in the rock matrix. Fracturing can occur quickly in intact chalk: Robinson and Jerwood (1967), in laboratory experiments observed erosion in 14 cycles and Murton et al. (2006) confirmed these results of macro-fracturing observations with 10 to 20 simulated successive freeze/thaw cycles. Given our observations on thermal variations, rock falls caused by freeze/thaw cycles would then occur preferentially at the top of the cliff face (Figure 2b, from the cliff edge, around temperature sensor S1 (21 m IGN69) to around S11 (16 m IGN69)). However, the degree of weathering that the chalk undergoes is much more advanced at the cliff foot than elsewhere along the cliff face, which is most likely due to saturation of the chalk at and below the cliff foot, as shown in the geophysical data, and to the addition of marine action at this location. This is consistent with Aldred et al. (2016), who observed that on different field sites in humid temperate climates, the moisture-availability can determine cracking rates. We suggest that this enhanced weathering at the cliff foot, which results from a combination of chemical actions from sea spray (under conditions of high tide and large waves) and groundwater circulation, leads to recurrent failures at this location (rockfalls and flakes) (Figure 11).
