Experimental field study on the fatigue and failure mechanisms of coastal chalk cliffs: Implementation of a multi-parameter monitoring system (Sainte-Marguerite-sur-Mer, France)

To appear in: *Geomorphology*

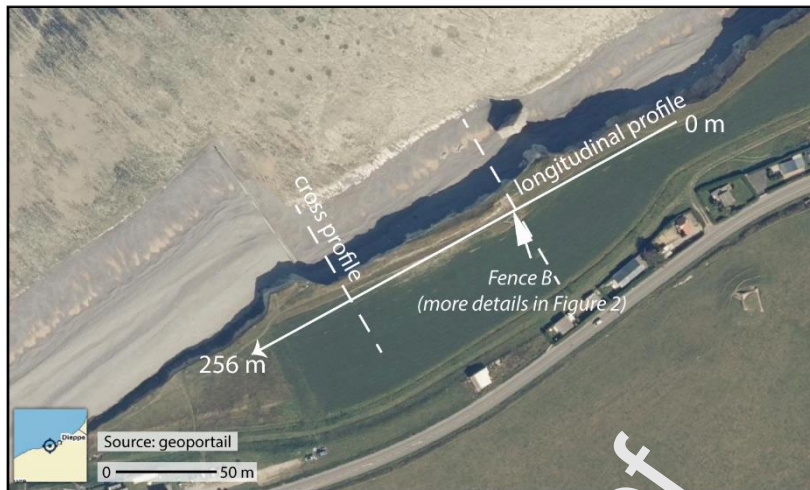
Figure 5: (a) Geophysical measurements location; (b) Ground Penetrating Radar (GPR) longitudinal profile (200 MHz, 12 m penetration depth); (c) Electrical Resistivity Tomography (ERT) longitudinal profile acquired on the cliff top, along the edge of the cliff, passing by

fence B (located in Figure 2). The common layer of investigated subsoil with GPR and ERT is delineated by the black dotted line. Note that the topography is enhanced in the GPR image; the depth scale differs compared with the ERT case.

The upper part of the chalk cliff is resistive enough to let electromagnetic waves propagate. The GPR depth of investigation is around 12 m (with an electromagnetic wave speed set at 1.3 m ns^{-1} , i.e. a dielectric constant of 5.3) and can be correlated with the resistivity pattern in the upper chalk layer. GPR signals between 60 and 200 m along the profile and down to a depth of 5 m reveal a heterogeneous chalk, probably resulting from open cracks filled with air and silt. Deeper (underneath the heterogeneous surface sub layer) and around this central area (at the extremities of the profile), radar signal strength has lower contrasts, indicating a homogeneous media compared with the wavelength (0.65 m) Figure 5b).

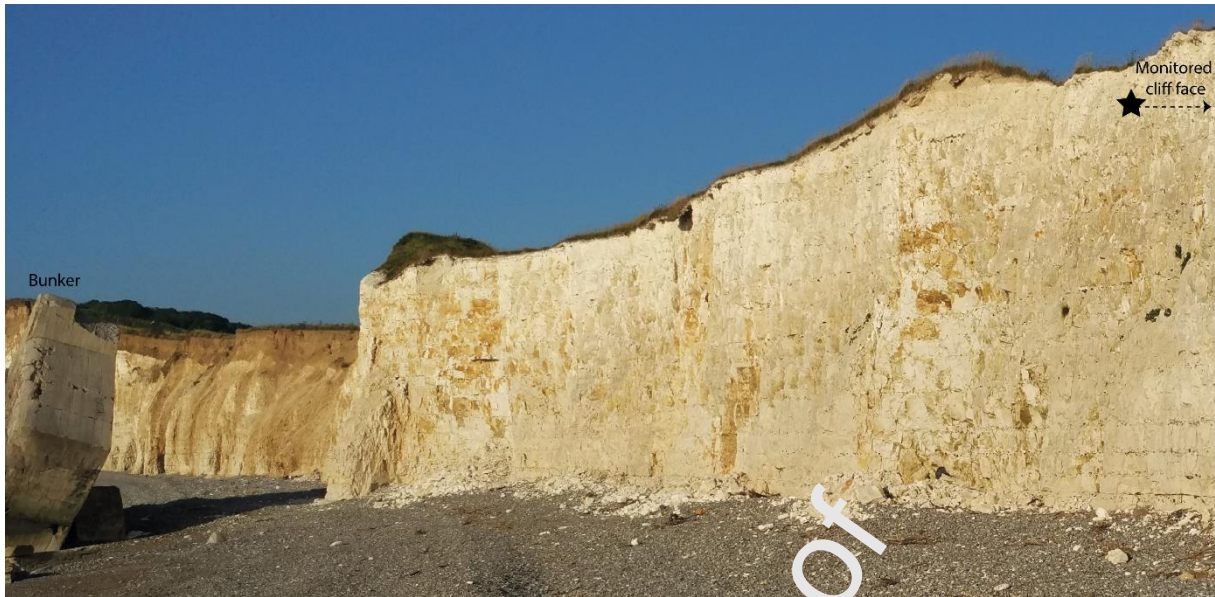
Figure 11: Rock falls and flakes observed in Sainte-Marguerite-sur-Mer (05/07/2018)

temperate climate (Aldred et al., 2016) and mid-latitude desert (McFadden et al., 2005; Eppes et al., 2015, 2010), cracks are preferentially observed in rock walls with northeast orientations. Insolation-related cracking is the main hypothesis, helped by other weathering processes at play (Aldred et al., 2016). A weathering mechanism that may be efficacious is the freeze/thaw cycles in the study site as they occur in a moisture-availability environment (Letavernier and Ozouf, 1987; Prick, 1995). Frost weathering leads to two processes: volumetric expansion and ice segregation (Matsuoka and Murton, 2008). As mentioned in Dewez et al. (2015), in Normandy, temperatures below 0°C (for fresh water) and below -2.5°C (for seawater) contract the rock while pore water freezes and dilates, leading to stress changes. These multidirectional strains accumulate and give rise to the breaking of pore walls and the appearance of micro-crack networks in the rock matrix. Fracturing can occur quickly in intact chalk: Robinson and Jerwood (1967), in laboratory experiments observed erosion in 14 cycles and Murton et al. (2006) confirmed these results of macro-fracturing observations with 10 to 20 simulated successive freeze/thaw cycles. Given our observations on thermal variations, rock falls caused by freeze/thaw cycles would then occur preferentially at the top of the cliff face (Figure 2b, from the cliff edge, around temperature sensor S1 (21 m IGN69) to around S11 (16 m IGN69)). However, the degree of weathering that the chalk undergoes is much more advanced at the cliff foot than elsewhere along the cliff face, which is most likely due to saturation of the chalk at and below the cliff foot, as shown in the geophysical data, and to the addition of marine action at this location. This is consistent with Aldred et al. (2016), who observed that on different field sites in humid temperate climates, the moisture-availability can determine cracking rates. We suggest that this enhanced weathering at the cliff foot, which results from a combination of chemical actions from sea spray (under conditions of high tide and large waves) and groundwater circulation, leads to recurrent failures at this location (rockfalls and flakes) (Figure 11).
