Experimental field study on the fatigue and failure mechanisms of coastal chalk cliffs: Implementation of a multi-parameter monitoring system (Sainte-Marguerite-sur-Mer, France)

To appear in: *Geomorphology*

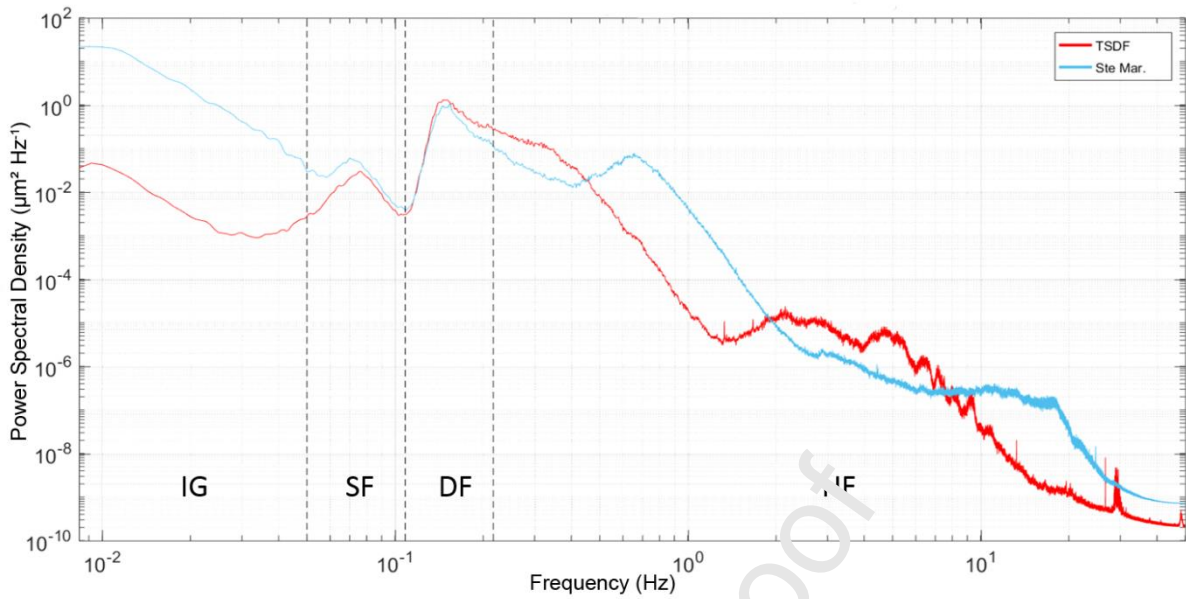
Figure 3: Power Spectral Density (PSD) of the displacement recorded by the seismometer on 13 November 2018, comparing between Sainte-Marguerite-sur-Mer station (Ste Mar.) and Thoiré-sur-Dinan (TSDf) inland station. The labels IG, SF, DF and HF indicate frequency bands, as explained in the text.

Figure 3 shows an example of PSD of vertical displacement for a selected day (13 November 2018), typical of mildly energetic hydrodynamic conditions. We verified that energy levels in the DF band were consistent between our cliff-top seismometer and the inland reference station. We calculated the total displacement energy within each of the four frequency bands.

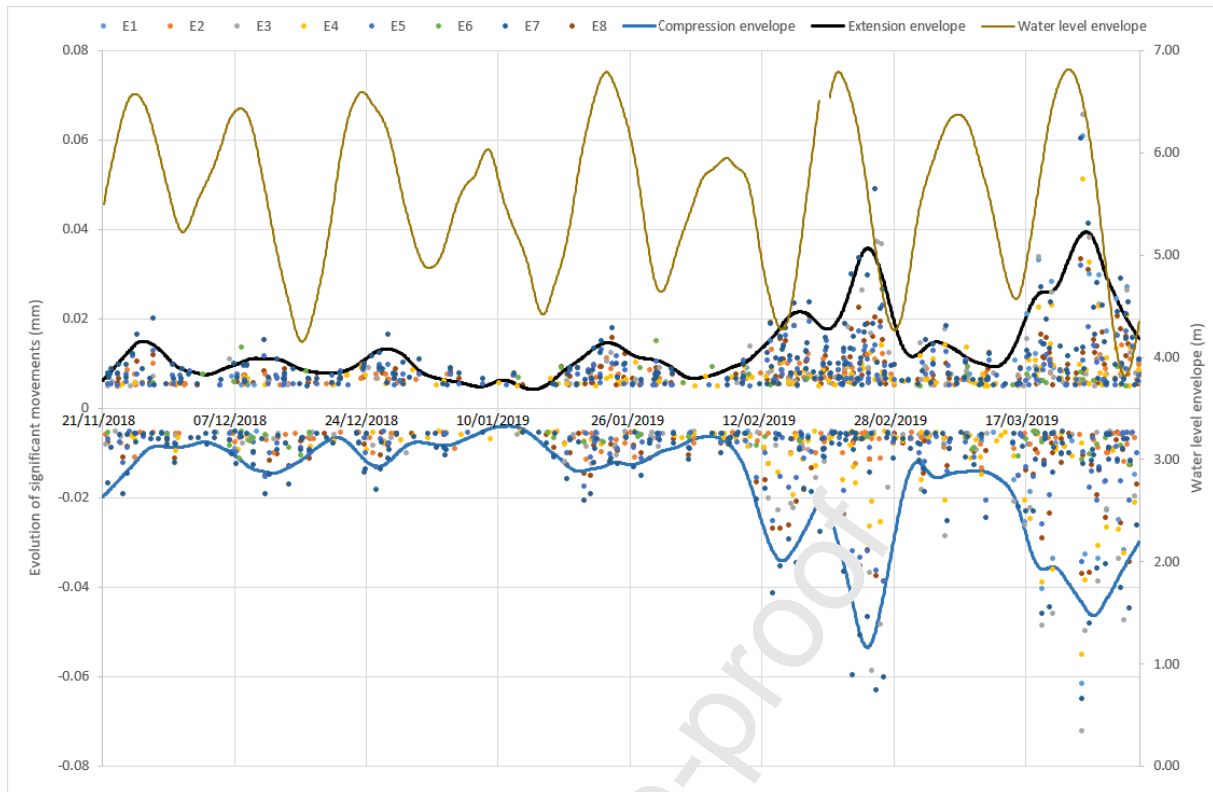
Figure 4: Extract of significant movement data from the eight extensometers (E, numbering from the middle (7 m IGN69) to the top of the cliff face (15 m IGN69) (Figure 2b)) from 21 November 2018 (00:00) to 31 March 2019 (22:00). The envelopes of the extension and the compression data considering all the extensometers are plotted in black and blue, respectively. The envelope of the water level data is plotted as well, to visualize the tidal cycles.

We applied bivariate and multivariate statistical methods on our dataset. Because temporal sampling was different from one instrument to the other, we use the lowest temporal sampling (2 h, for the weather station) as our time scale. The data series of all the other instruments were resampled at two-hour intervals. The data of the eight extensometers were filtered using a 5 μm threshold for the range beyond which evolutions were considered as significant (values between -5 μm and 5 μm are considered as not significant) (Figure 4).

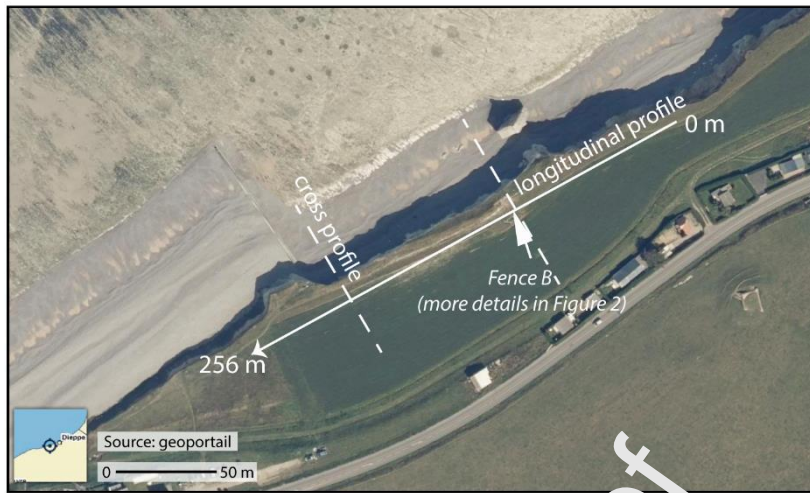
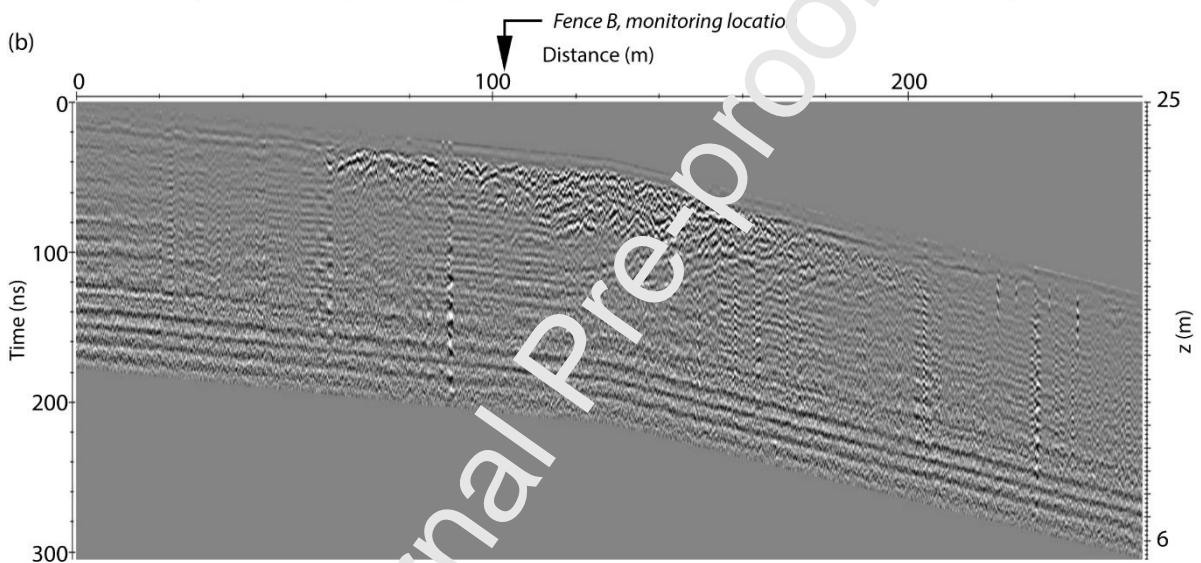
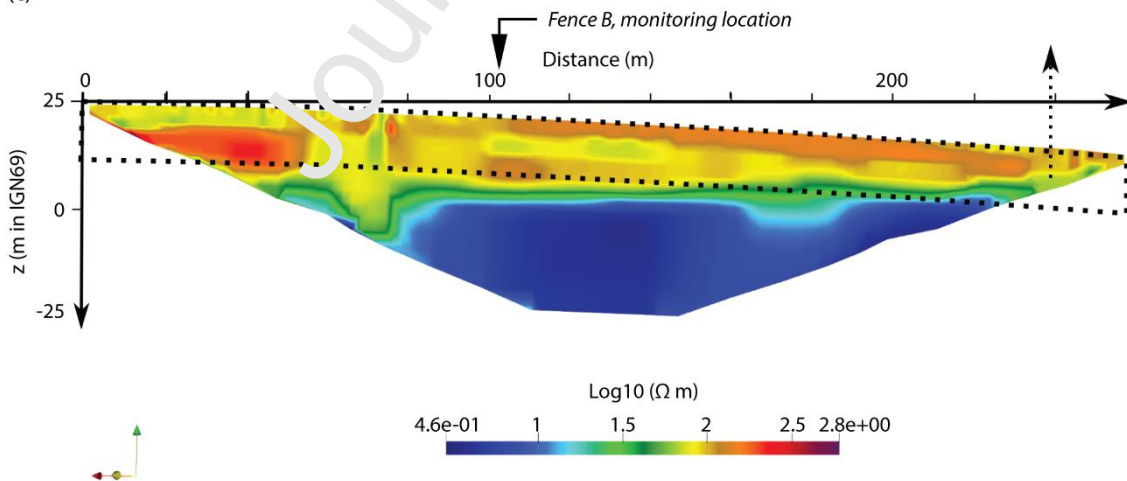
Figure 5: (a) Geophysical measurements location; (b) Ground Penetrating Radar (GPR) longitudinal profile (200 MHz, 12 m penetration depth); (c) Electrical Resistivity Tomography (ERT) longitudinal profile acquired on the cliff top, along the edge of the cliff, passing by

fence B (located in Figure 2). The common layer of investigated subsoil with GPR and ERT is delineated by the black dotted line. Note that the topography is enhanced in the GPR image; the depth scale differs compared with the ERT case.

The upper part of the chalk cliff is resistive enough to let electromagnetic waves propagate. The GPR depth of investigation is around 12 m (with an electromagnetic wave speed set at 1.3 m ns^{-1} , i.e. a dielectric constant of 5.3) and can be correlated with the resistivity pattern in the upper chalk layer. GPR signals between 60 and 200 m along the profile and down to a depth of 5 m reveal a heterogeneous chalk, probably resulting from open cracks filled with air and silt. Deeper (underneath the heterogeneous surface sub layer) and around this central area (at the extremities of the profile), radar signal strength has lower contrasts, indicating a homogeneous media compared with the wavelength (0.65 m) Figure 5b).

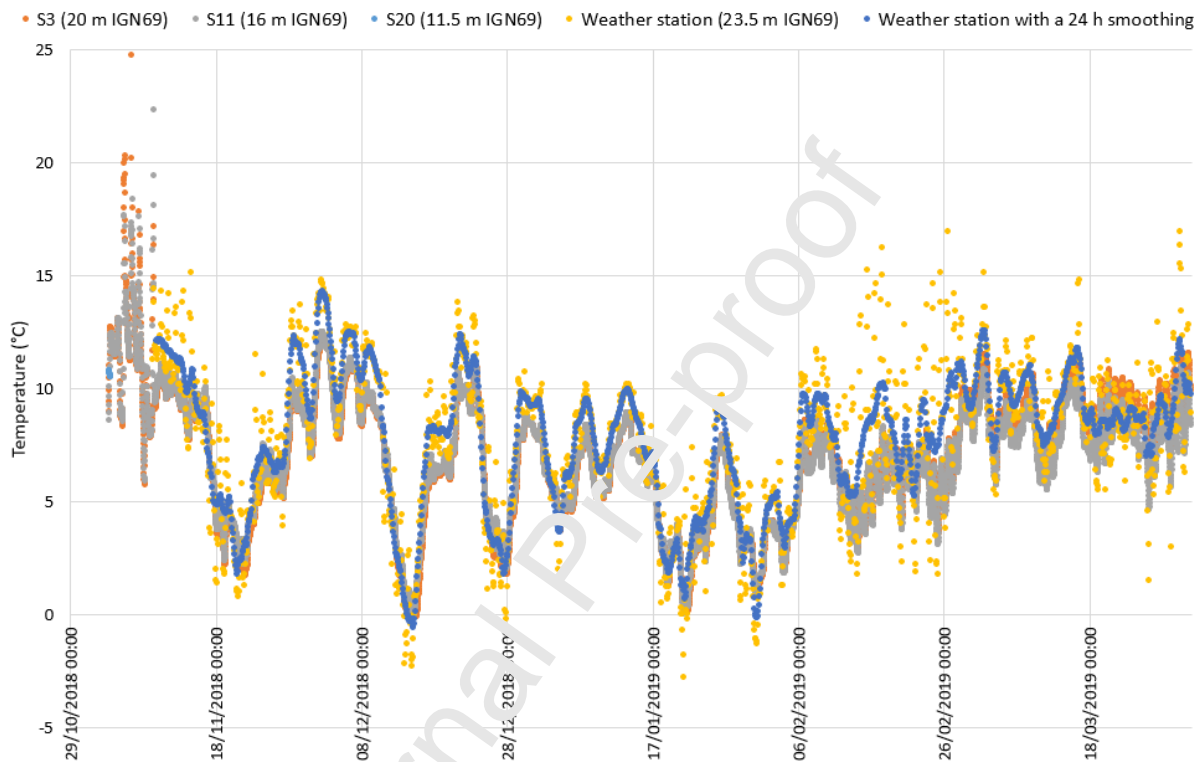
Figure 7: Temperature sensors at the subsurface of the cliff face from November 2018 to March 2019 (S3: sensor 3 located at 20 m IGN69, S11: sensor 11 located at 16 m IGN69, S20: sensor 20 located at 11.5 m IGN69; weather station located on the plateau at 23.5 m IGN69 (Figure 2)).

The subsurface temperature sensors array shows a good agreement with the weather station located on the cliff top (23.5 m IGN69). Higher frequency signals are present in the weather station records. The 24 h smoothing of weather station data shows a good fit with, for instance, sensors 3, 11, and 20 (20 m, 16 m and 11.5 m IGN69, respectively, Figure 2b) (Figure 7).

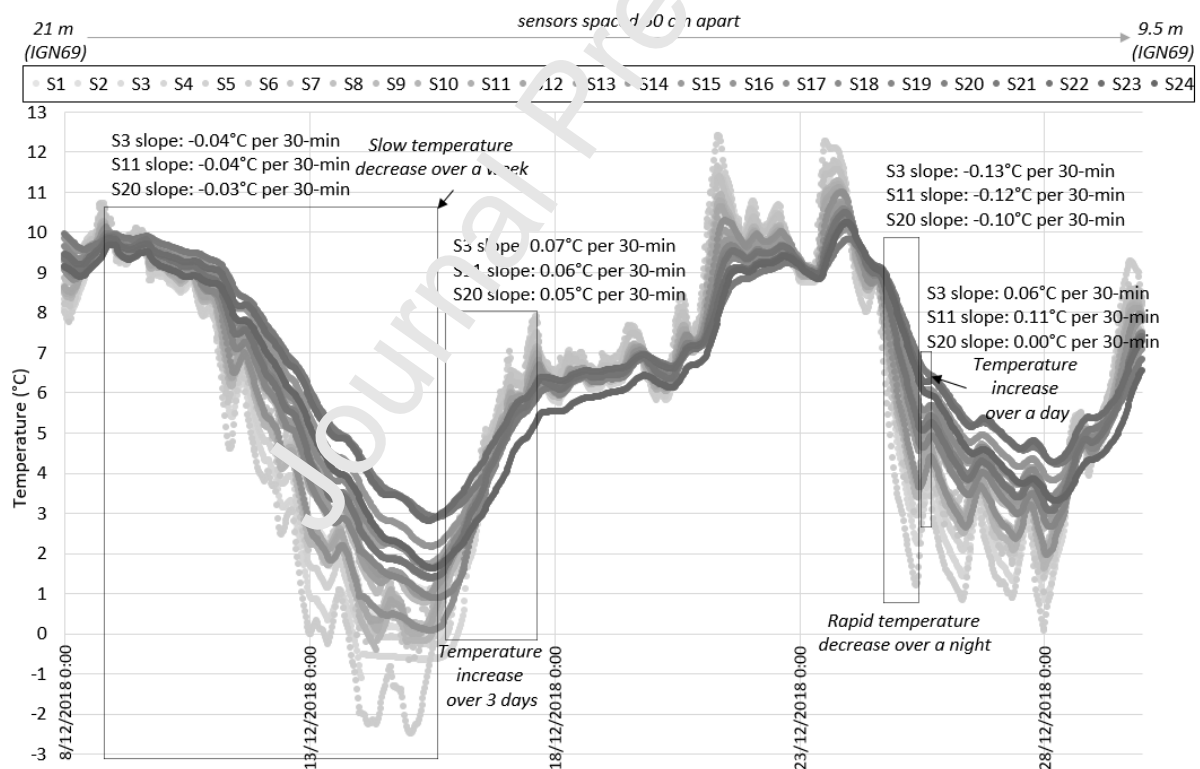
Figure 8: Temperature sensor comparison from 8/12/2018 to 28/12/2018 for the 24 sensors (numbering from the top to the bottom of the cliff face) showing temperature increase gradients for sensors 3 (S3), 11 (S11) and 20 (S20).

In the case of a decrease of external temperature over a week, from 8/12/2018 (21:00) to 15/12/2018 (05:00), the gradients of the subsurface sensors 3, 11 and 20 are -0.04°C per 30-min, -0.04°C per 30-min, -0.03°C per 30-min, respectively. In the case of a rapid decrease of external temperature over a night, from 24/12/2018 (18:30) to 25/12/2018 (09:30), the gradients of the subsurface sensor 3, 11 and 20 are -0.13°C per 30-min, -0.12°C per 30-min, -0.10°C per 30-min, respectively. In the case of an increase of external temperature over 3 days, from 15/12/2018 (17:00) to 17/12/2018 (15:30), the slopes of the subsurface sensors 3, 11 and 20 are 0.07°C per 30-min, 0.06°C per 30-min, 0.05°C per 30-min, respectively. In the case of an increase of external temperature over a day, 25/12/2018 (09:30–15:30), the slopes of the subsurface sensors 3, 11 and 20 are 0.06°C per 30-min, 0.11°C per 30-min, 0.00°C per 30-min, respectively. This behaviour highlights a decrease in thermal inertia from the top to the bottom of the cliff (Figure 8).
